# RESERVE STUDY

## Council of Unit Owners Mutual 19B Condominium of Rossmoor, Inc.

**Silver Spring, Maryland**  
**October 19, 2021**

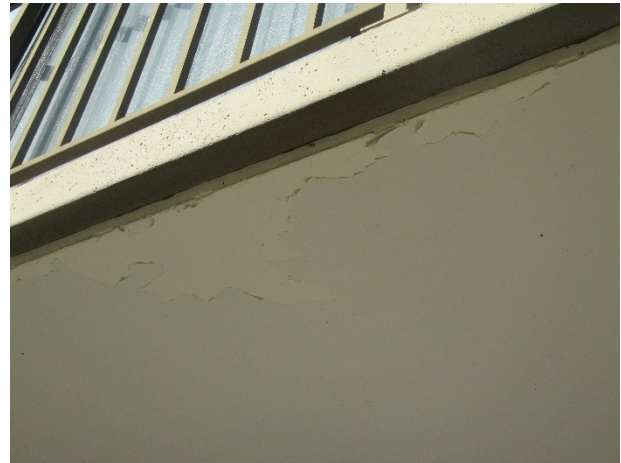
**Condition:** Good to fair overall with finish deterioration and carpets on balconies evident. As mentioned, we note carpet at the balconies. Carpet conceals concrete deterioration, retains water and inhibits drainage. Water trapped by the carpet can result in accelerated concrete deterioration. Therefore, we do not recommend the use of carpet on balcony surfaces.

**Finish deterioration**

**Useful Life:** Capital repairs including a close-up visual inspection, patching of delaminated concrete, routing and filling of cracked concrete, and waterproof coating applications every 8- to 12-years.

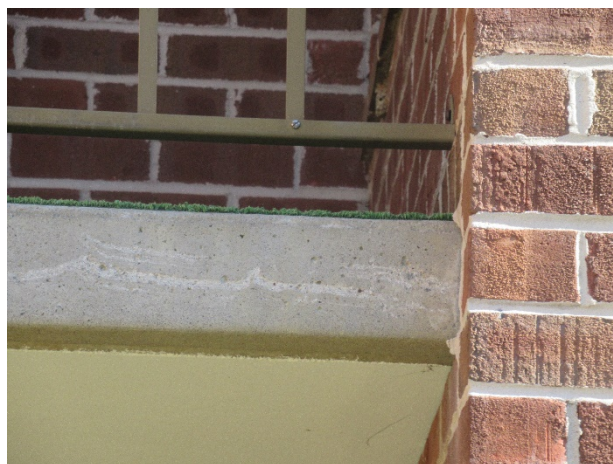
**Carpet on balcony**

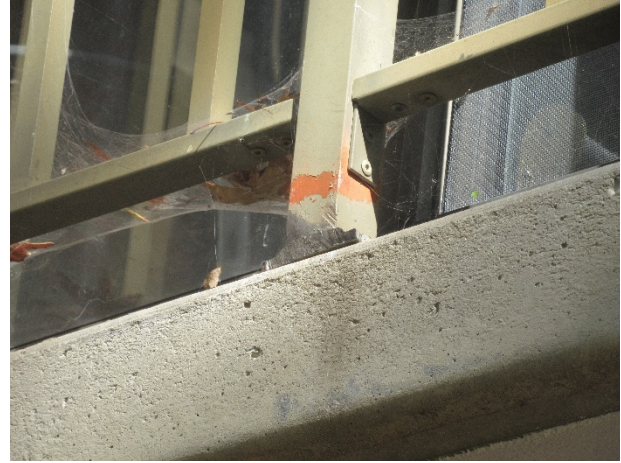
**Condition:** Fair overall with fade and finish deterioration evident

**Finish deterioration**

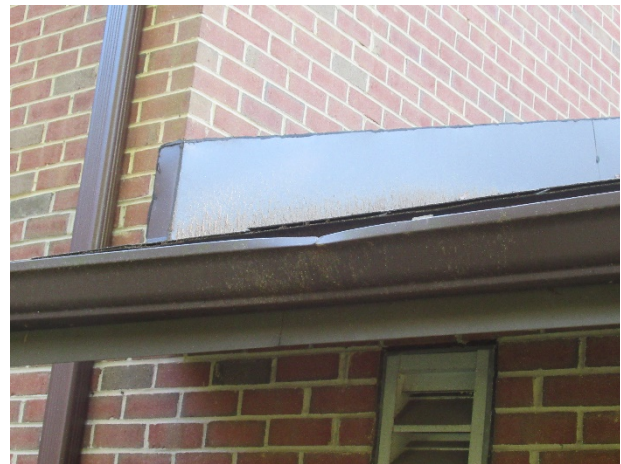
**Condition:** Good overall with isolated damage evident

**Isolated gutter damage**

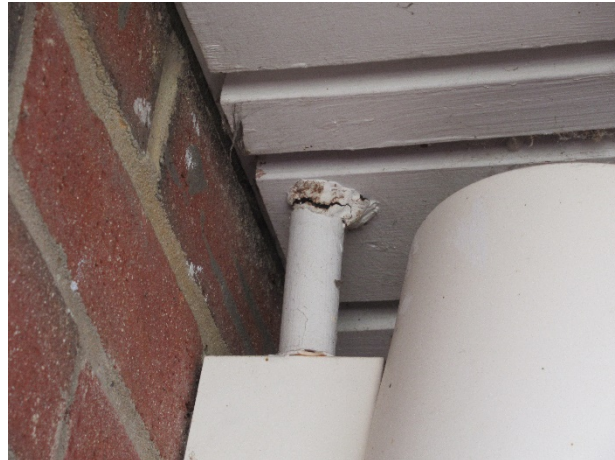
**Condition:** Fair overall with minor rust and finish deterioration evident

**Minor rust**

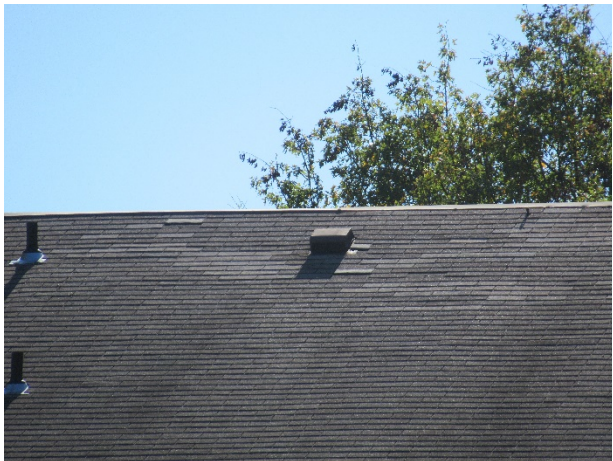
**Condition:** The roof at building 91 is in good condition overall. The roofs at the remaining buildings are in good to fair condition with shingle lift, sheathing deflection and isolated missing shingles evident. The Board informs us of a history of leaks with recent repairs conducted.

**Isolated missing shingles**

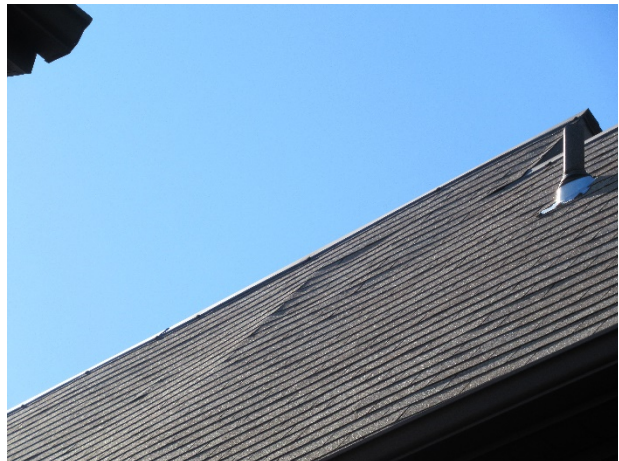
**Sheathing deflection**

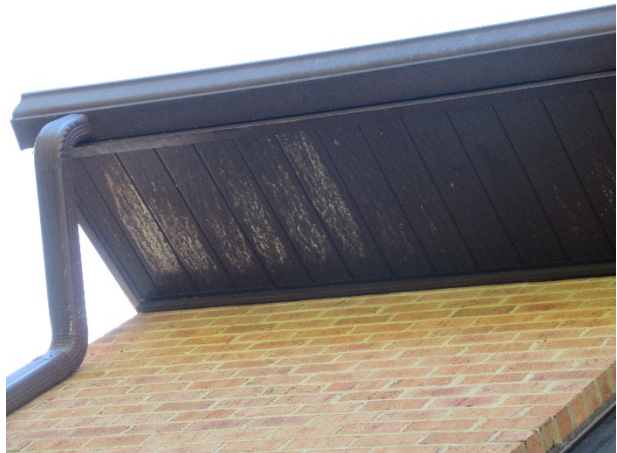
**Condition:** Good to fair overall with finish deterioration evident

**Finish deterioration**

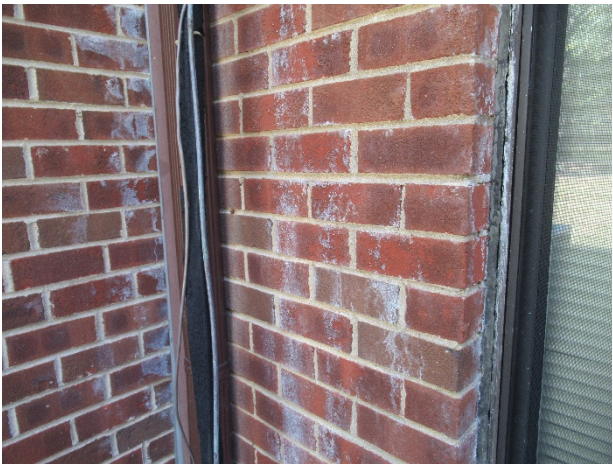
**Efflorescence at building 94**

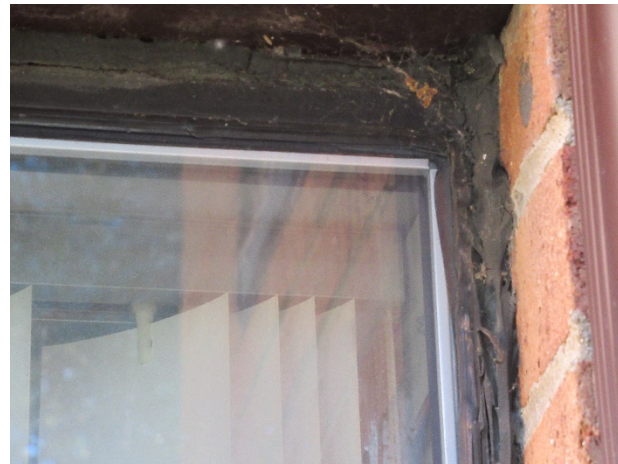
**Sealant deterioration at building 93**

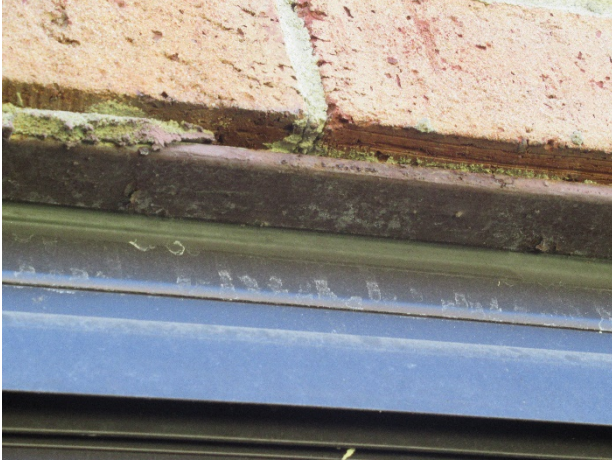
**Lintel rust and mortar deterioration at building 93**

We recommend an inspection, repair and replacement of the steel lintels. Lintels are structural supports or beams above windows and doors. Fatigued lintels also allow the direct penetration of storm water into the wall assembly. These inspections should locate areas of rust on the lintels and cracks or other structural damage to the walls around lintels. The contractor should remove any areas of rust, prime and paint these lintels. Paint protects and maximizes the remaining useful life of the lintels and therefore the exterior wall systems. Structural damage can eventually lead to costly replacements of lintels and surrounding wall systems. The following diagram details a typical metal lintel and weep system and may not reflect the actual configuration at Mutual 19B:

The contractor should remove any areas of rust, prime and paint exposed shelf angles at windows. The following diagram details a typical metal lintel and weep system, however, this detail is similar to construction at shelf angles and may not reflect the actual configuration at Mutual 19B:

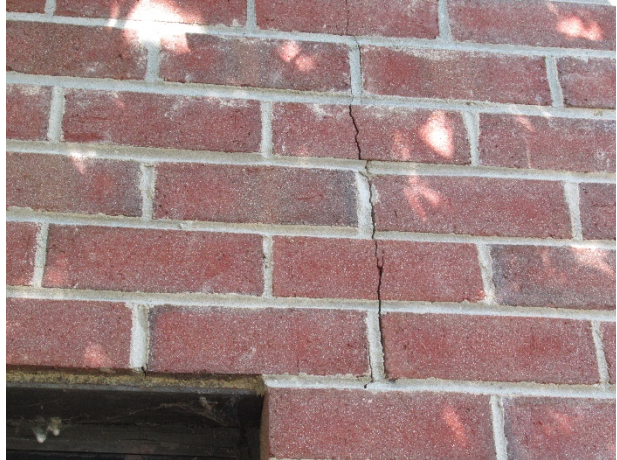
**Masonry and mortar cracks at building 92**

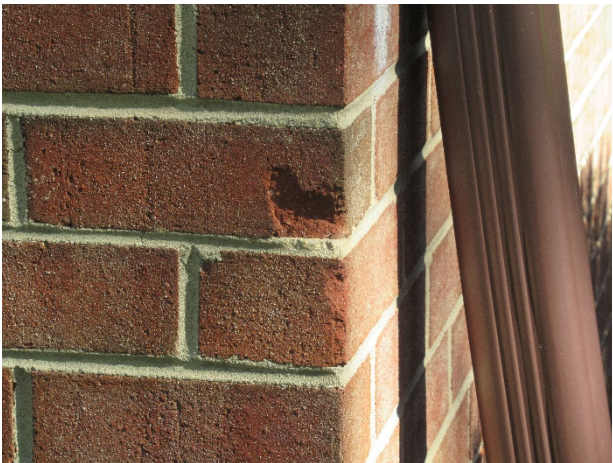
**Masonry spall at building 92**

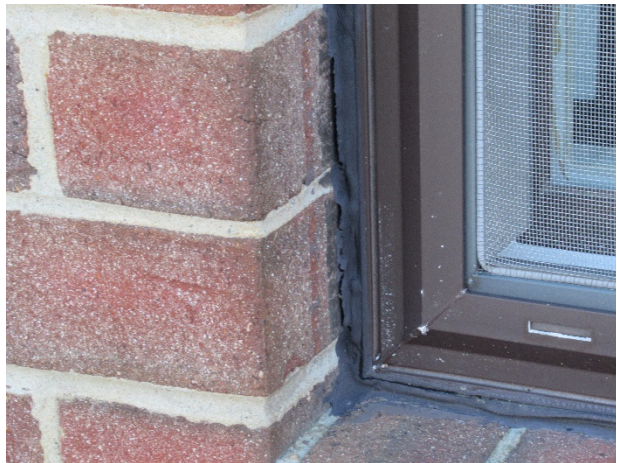
**Sealant cracks at building 92**

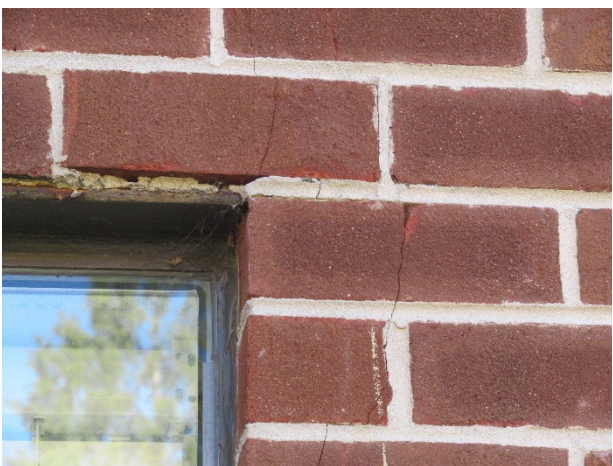
**Masonry cracks and mortar deterioration at building 90**

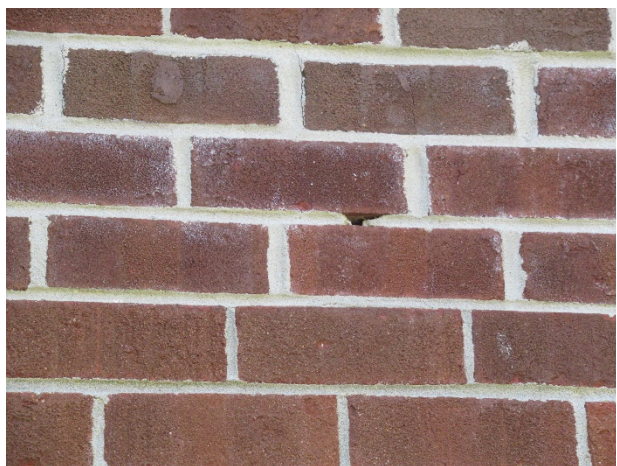
**Efflorescence and mortar deterioration at building 90**

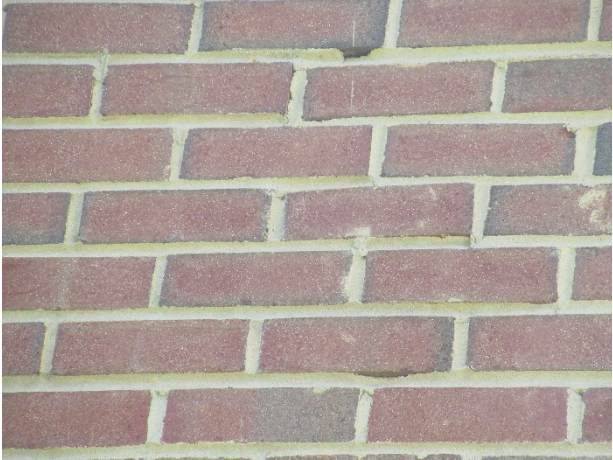
**Mortar deterioration at building 89**

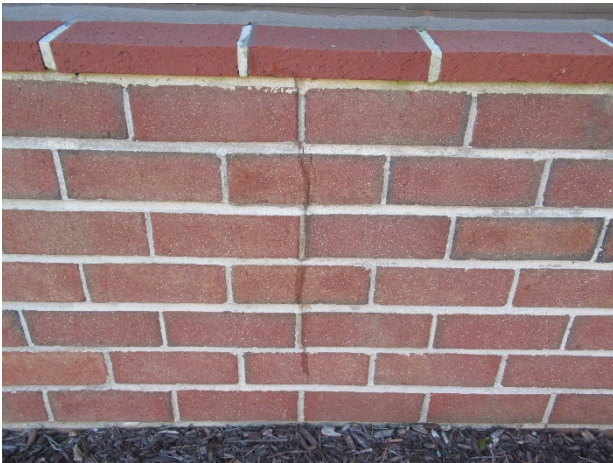
**Masonry crack at building 88**

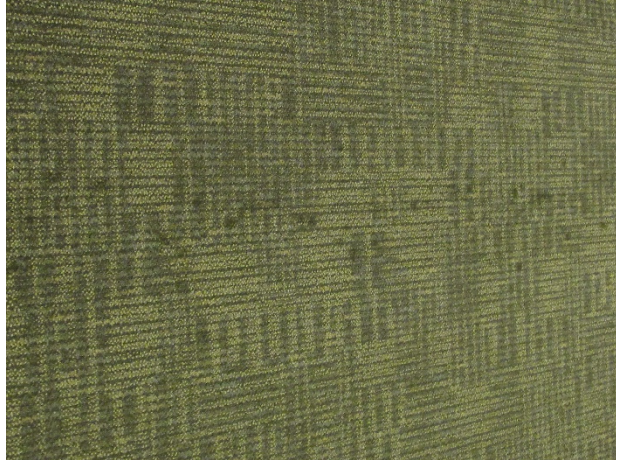
**Stains**

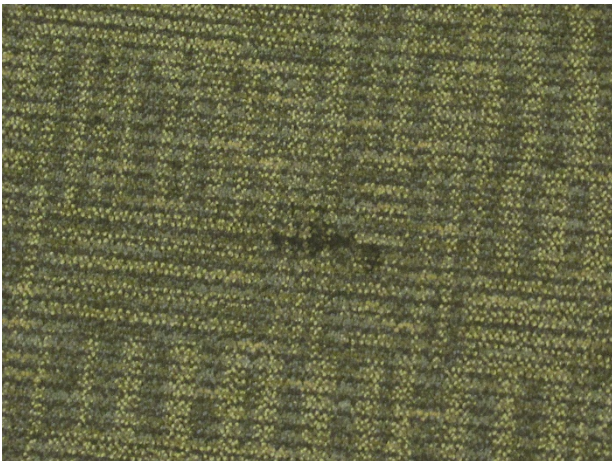
**Stains**

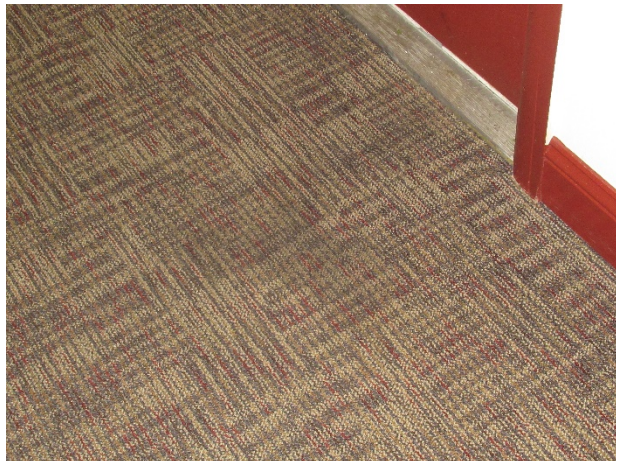
**Stains**

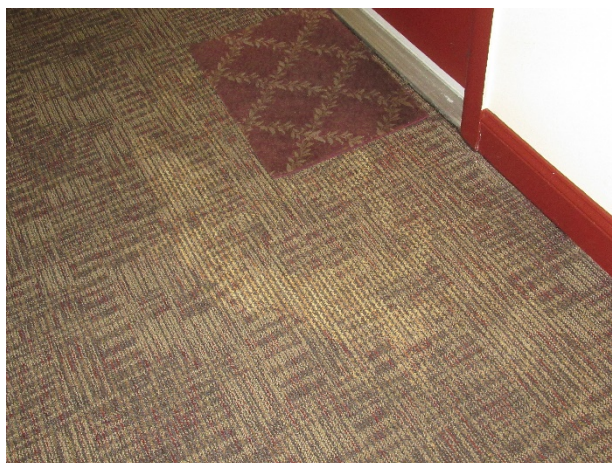
**Stains**

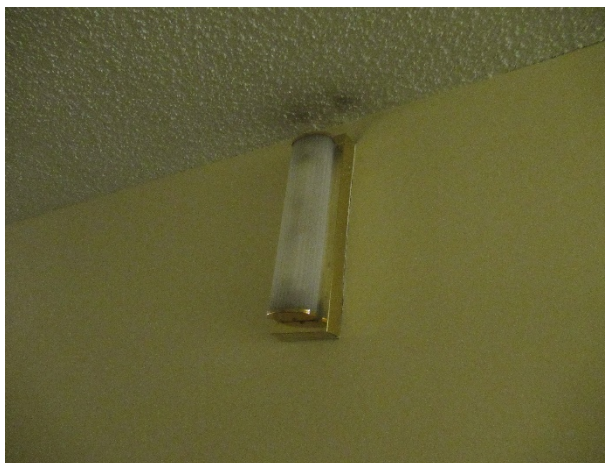
Finish deterioration and burnt out bulb

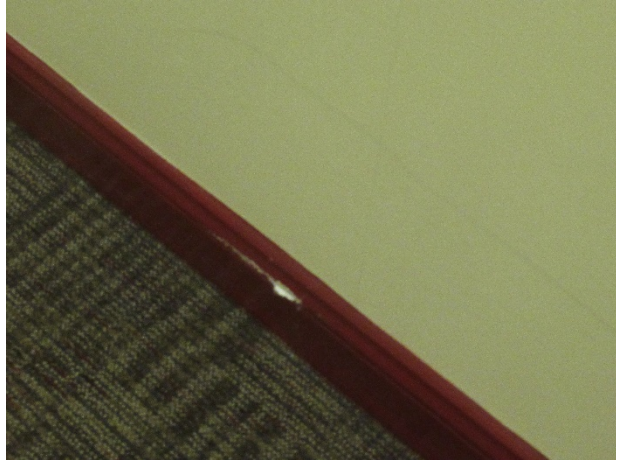
**Damage**

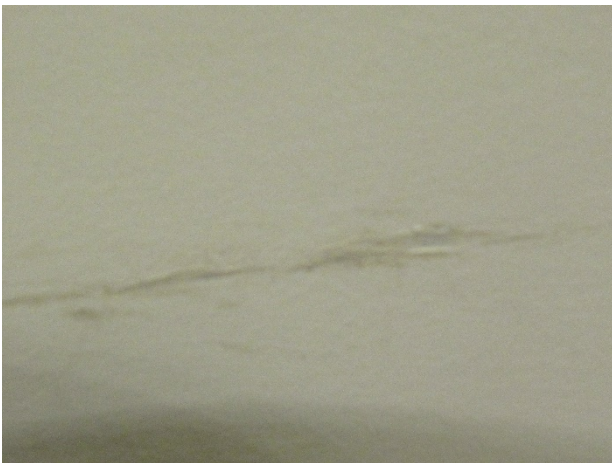
**Scuff mark and damage**

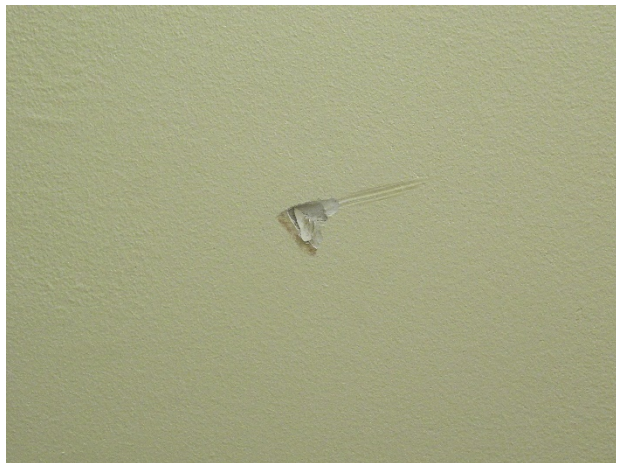
**Damage**

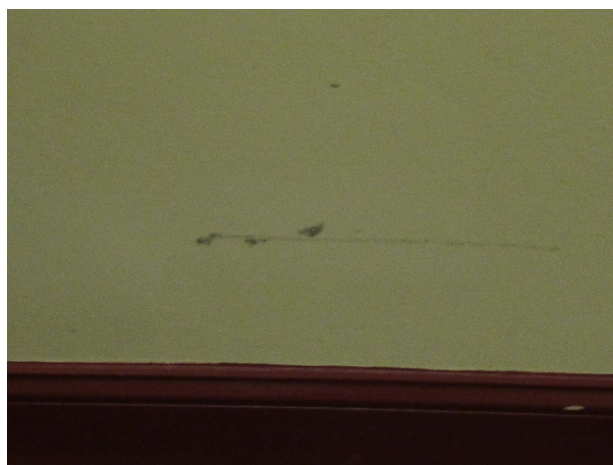
**Scuff mark**

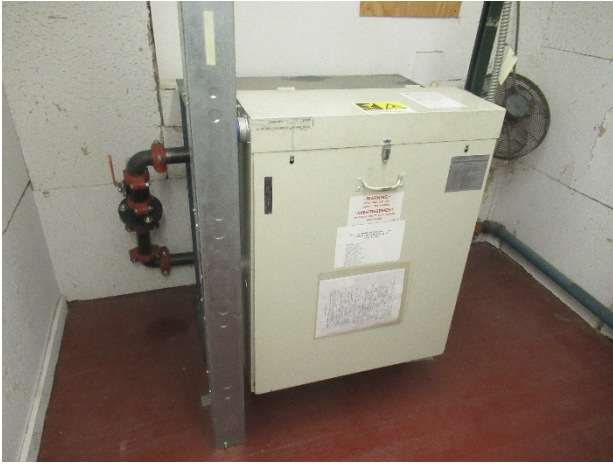
**Condition:** Reported in unsatisfactory condition

**Elevator controls, 2001 replacement**

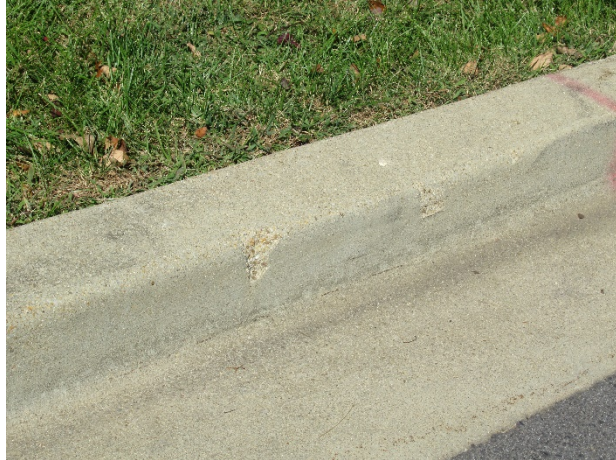
**Condition:** Good overall with isolated concrete spall

**Isolated concrete spall**

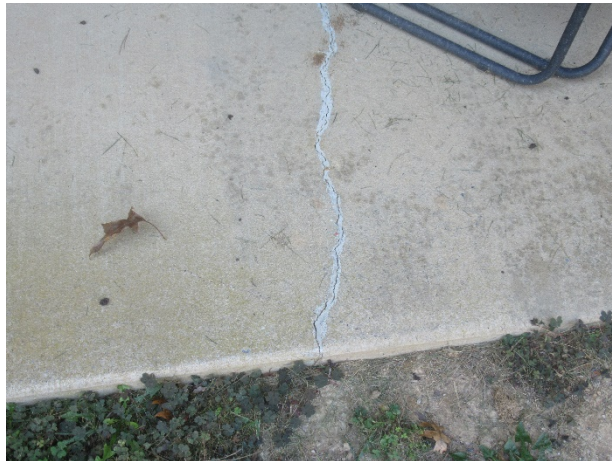
**Condition:** Good to fair overall condition with carpets on patios and cracks evident. As mentioned, we note carpet at the patios. Carpet conceals concrete deterioration, retains water and inhibits drainage. Water trapped by the carpet can result in accelerated concrete deterioration. Therefore, we do not recommend the use of carpet on patio surfaces.

**Patio crack**

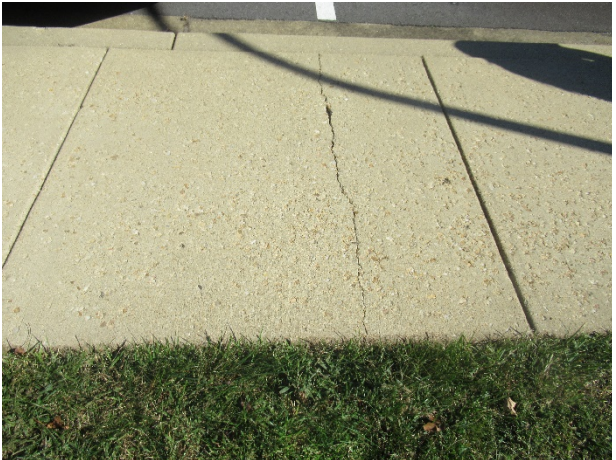
**Concrete scaling and crack**

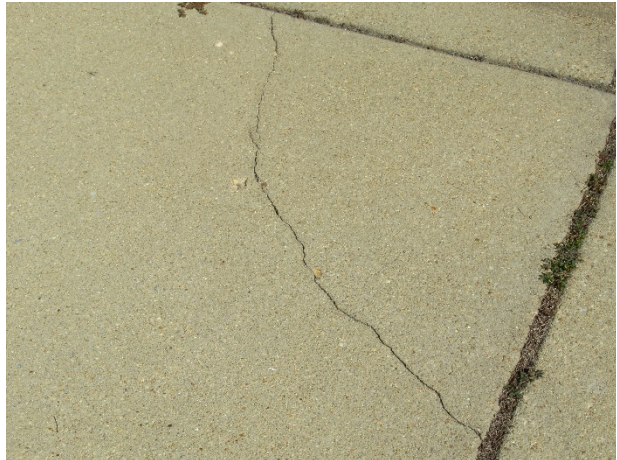
**Concrete sidewalk crack**

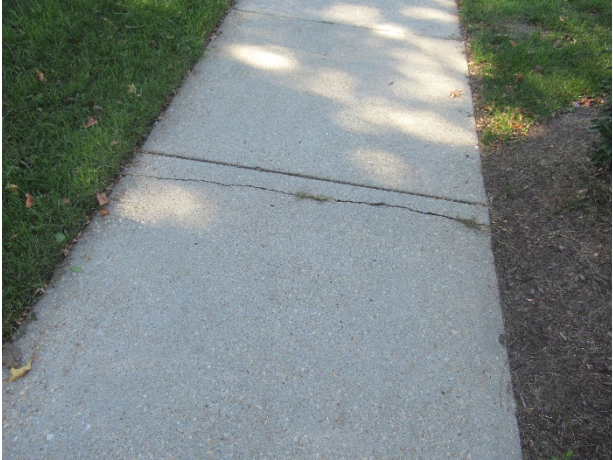
**Concrete sidewalk crack**

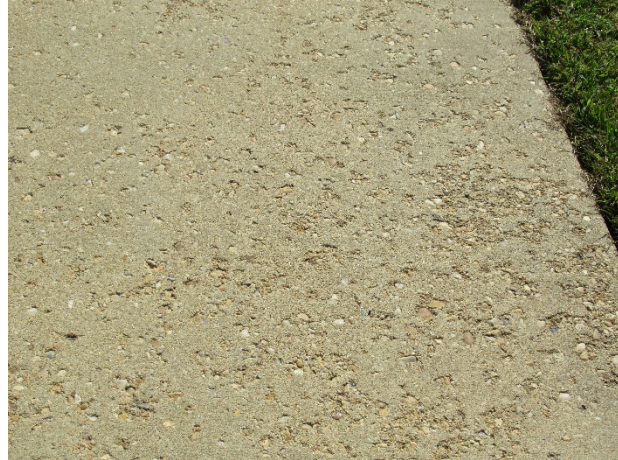
**Concrete sidewalk scaling**

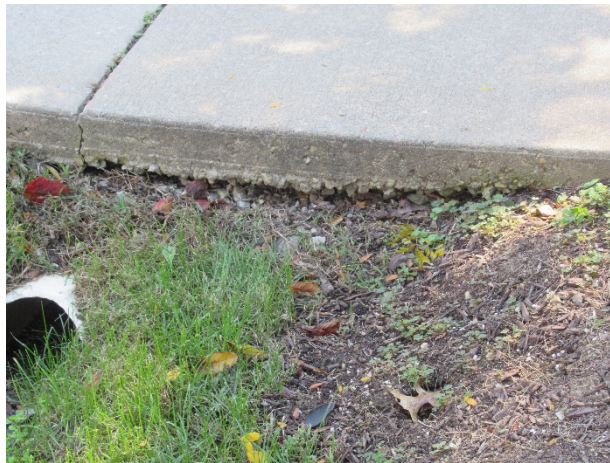
**Concrete sidewalk undermining**

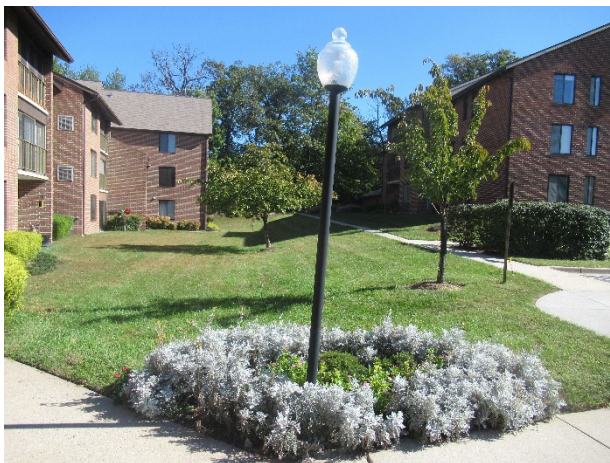
**Condition:** Good to fair overall with isolated lean evident

**Light pole and fixture overview – Note: lean**
