Project 180181 – Task Order 1: Storm Water Analysis/Gutter and Downspouts, Mutual 19B,  
Leisure World, Silver Spring, MD 20906

At the request of O'Connell and Lawrence, Inc. (OC&L), Simpson Gumpertz & Heger Inc. (SGH) performed a condition assessment and drainage analysis of the existing steep- and low-sloped roofing assemblies and integrated drainage components at the above-named project. This letter summarizes our observations and presents our conclusions and recommendations.

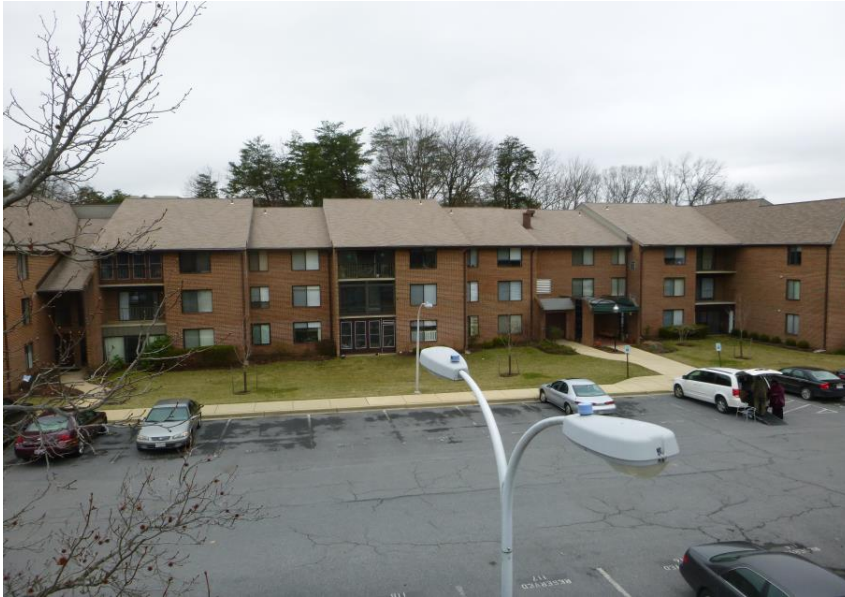
**Photo 1**

View of the north elevation of Building 88. The typical steep-slope roof layout consists of multiple roof areas separated by a rising wall, typically at changes in plane of the building wall.

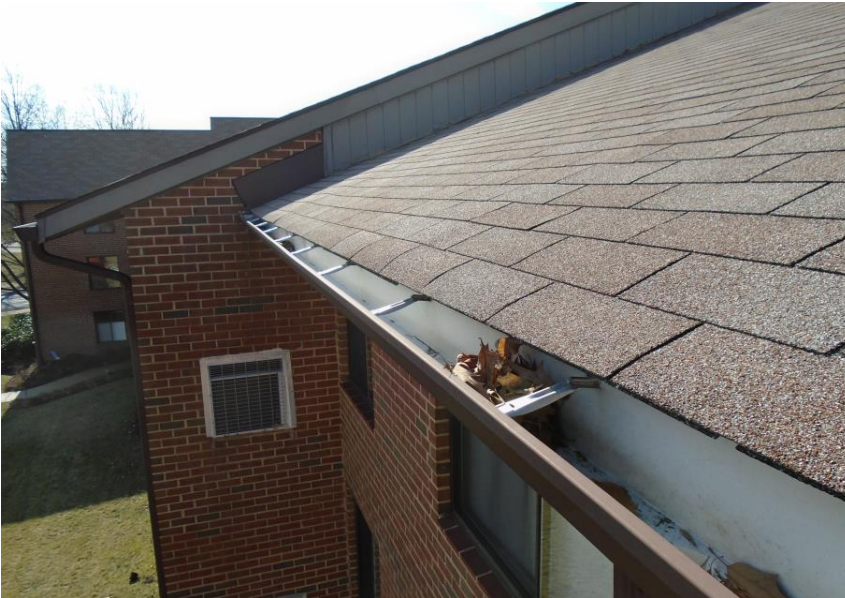
**Photo 2**

View of a section of the K-style aluminum gutter along the steep-slope roof eave.

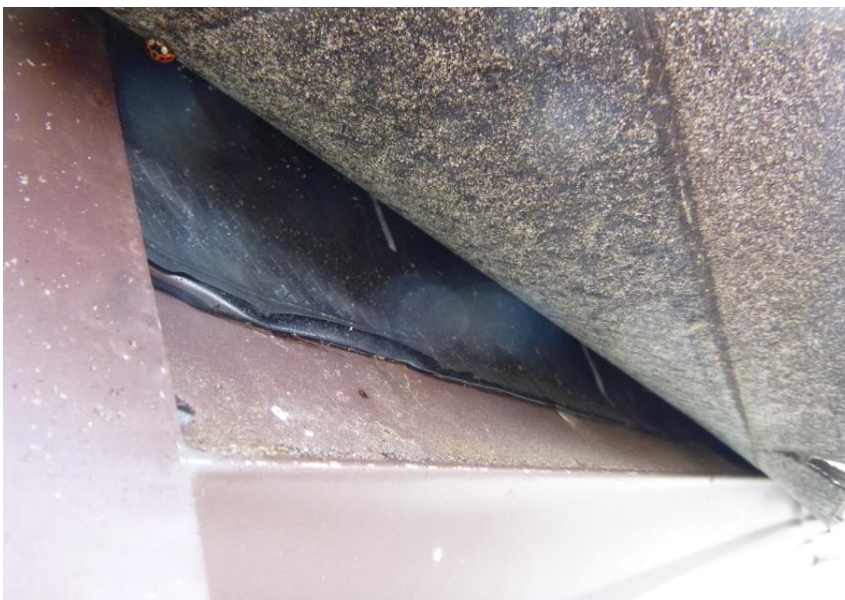
**Photo 3**

- A black self-adhered membrane underlayment is installed below the asphalt shingles at several areas we observed, typically along the roof edges. The underlayment shingle-laps over the horizontal leg of a metal counterflashing along the roof eave (Photo 3).

View of the membrane underlayment along the eave edge of a section of the Building 88 roof.

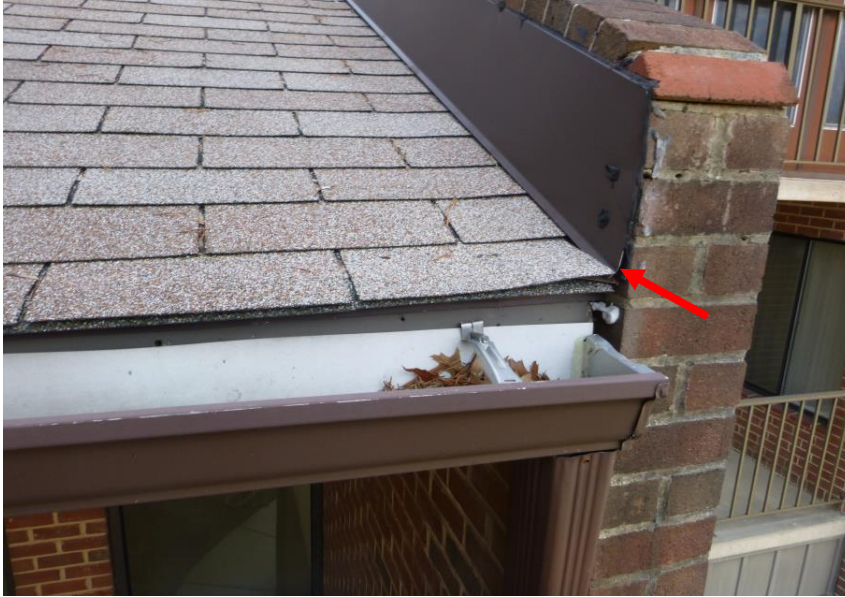
**Photo 4**

- A surface-sealed metal flashing extends to the top surface of the asphalt shingles at areas where the roofing abuts adjacent masonry walls (Photo 4). We were not able to confirm if the roofing underlayment extends up the wall below the flashing. A smaller L-shaped metal flashing extends out from below the edge of the roof shingles and approximately 2 in. (visual estimate) up the adjacent brick masonry wall, behind the counterflashing. The L-shaped flashings are sealed to the brick at the select areas we could observe. Seals appear generally intact with some areas of dry or cracked sealant.

View of the steep-slope roof to building wall transition over the stair tower entrance near the northeast corner of the building. An L-shaped metal flashing extends up the brick masonry wall from below the edge shingles, behind the counterflashing (arrow).

We were not able to confirm the termination of the steep-slope roofing and steep-slope roofing underlayment against the building walls. We suspect the underlayment terminates against the brick masonry building wall behind the surface-sealed counterflashings. Such terminations rely on intact and continuous sealant to prevent water intrusion behind the counterflashings and below the roofing underlayment. The counterflashings will increase the durability of the underlayment termination, but such a condition still relies on sealant continuity along the top edge. Masonry walls are porous, and some moisture will enter the brick and can bypass surface-sealed terminations. We do not know the configuration of the wall-to-roof transition at these locations, and we did not observe evidence of or receive occupant reports to suggest that water is entering under the roofing or into the building at these locations. Building maintenance staff should continue to monitor these areas for leaks and regularly review the surface-sealed roofing terminations to identify and replace worn sealant to maintain current performance.

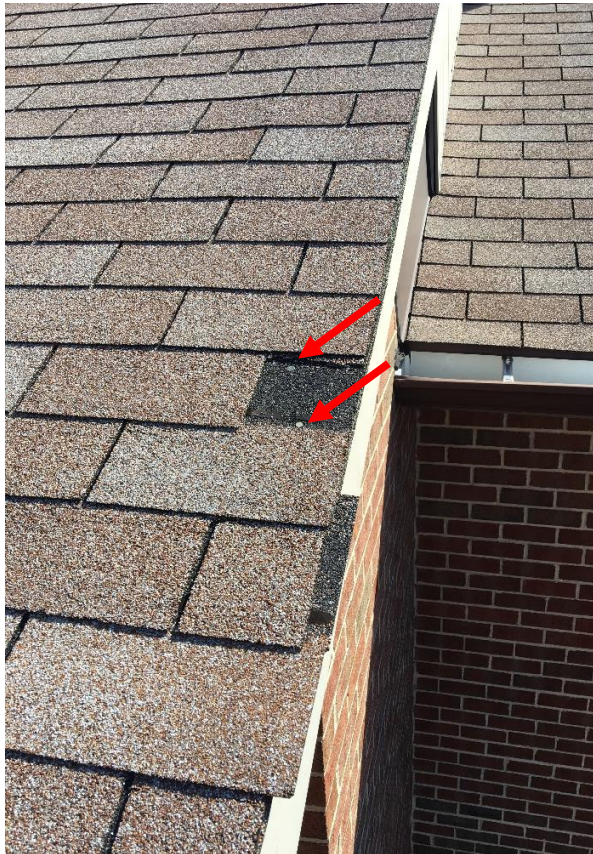
**Photo 5**

- The asphalt shingles are evenly coursed and are generally intact with limited areas of displaced or missing shingles. At isolated areas, shingles are unadhered or are missing, exposing the mechanical fasteners and the asphaltic portion of the underlying shingles (Photo 5).

View of the shingle fastener heads and exposed asphalt at a missing shingle location (arrows).

Asphalt shingle roofs rely on the roof slope and shingle-lapping successive shingles to shed water past fasteners and into the dedicated gutters at the base of the slope. We observed isolated areas where shingles were displaced or missing, exposing the adjacent shingle fastener heads and portions of the shingles without impregnated granules (i.e., exposed asphalt). Exposed fasteners are more susceptible to water leakage. We were not able to access the interior areas directly below the missing shingle locations. However, we suspect that leakage is not ongoing due to lack of reports from residents. An asphalt fiberglass roofing shingle is a composite of different materials combined to provide water-shedding capability on a steep-sloped roofing system. Asphalt fiberglass shingles are manufactured from a fiberglass fabric-like felt that is impregnated and coated with an asphaltic material (asphalt and mineral filler/stabilizer) and then surfaced on the top (weather side) with mineral granules and on bottom (reverse side) with minerals used to prevent shingles from sticking in the packaging. The asphaltic layer of the shingles is susceptible to degradation when exposed for extended periods of time to ultraviolet radiation. Targeted shingle replacement to protect fastener penetrations and the asphaltic layer of the shingles may prolong the useful life of the roofing system and reduce the risk of water leakage into the residencies below.

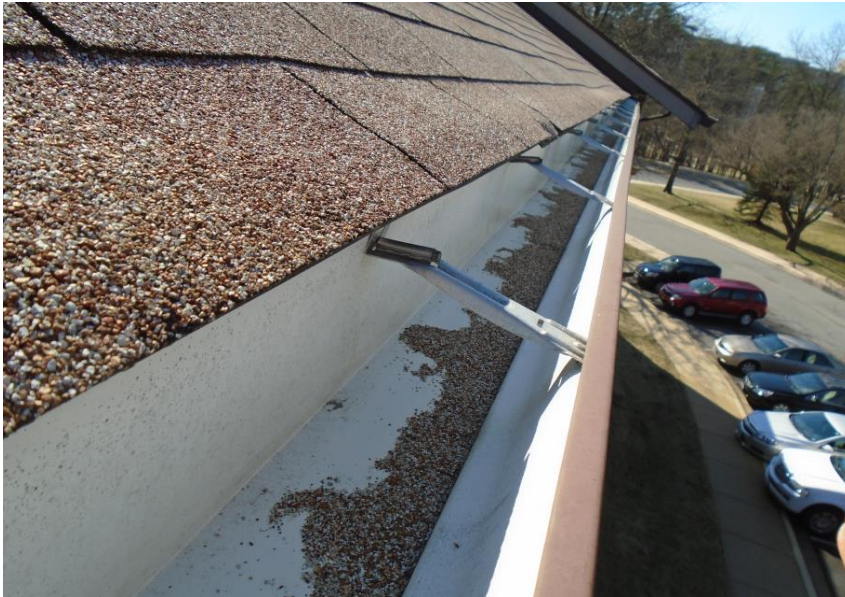
**Photo 6**

- In several areas, the colored granules that are impregnated into the top surface of the asphalt shingles have displaced and accumulated within the hung gutters (Photo 6). We observed limited areas where displaced granules had exposed the asphalt layer of the shingles.

We observed several areas where granules that have unadhered from the asphalt shingles have accumulated within the gutters at the base of the roof slope. This is normal as an asphalt shingle roofing system ages. The mineral granules used on the exposed surface of the asphalt shingle provide weight for wind resistance and protect the asphalt from ultraviolet radiation degradation. The measurable loss of the granule surfacing expedites the photo-oxidation of asphalt and reduces the life of the shingle. While we observed accumulation of granules within the gutters,

View of shingle granules accumulated within a section of gutter along the west elevation of the building.

we observe limited areas where the asphalt layer of the shingles was readily visible. We expect that through the life of the roof, the granules will continue to displace and continue to expose the asphalt layer of the shingles. At some point, enough of the granules will be displaced and enough of the asphalt layer will be exposed to warrant asphalt shingle roofing replacement, but this is not the current circumstance. Asphalt shingle roofing usually comes with an expected normal condition service life (for example, the term “a 30-yr shingle”), which is usually a good timeframe after which to consider asphalt shingle replacement. Building maintenance staff should determine the life expectancy of the existing asphalt shingles at the time they were installed to estimate remaining shingle service life, and continue to monitor the asphalt shingle roofing as it ages.

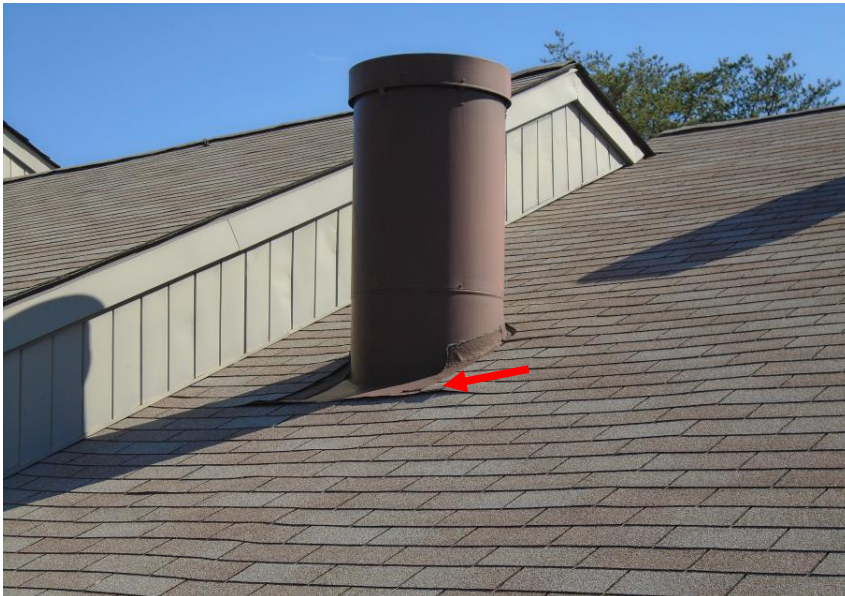
**Photo 7**

View of a vent stack penetration in the steep- slope roofing (arrow).

The vent stack penetrations through the steep-slope roofing assembly generally include a rectangular metal flange extending out on all sides of the stack. The flange is typically stripped in by shingles. However, isolated shingles have been displaced or are lifting along the stack flange edges, leaving the penetrations vulnerable to leakage from water runoff or sliding snow. We were not able to observe the integration of the vent stack with the roofing underlayment. It is good roofing practice to strip in roofing penetrations with self-adhered roofing underlayment to reduce the potential for water leakage. While we do not know of any reported water leakage at these locations, water leaks may begin to develop as the roof ages, and if the stack flanges become exposed. Potential repair may include removing and replacing a portion of the shingles surrounding the vent stack flange and stripping in the flange with a self-adhered membrane underlayment.

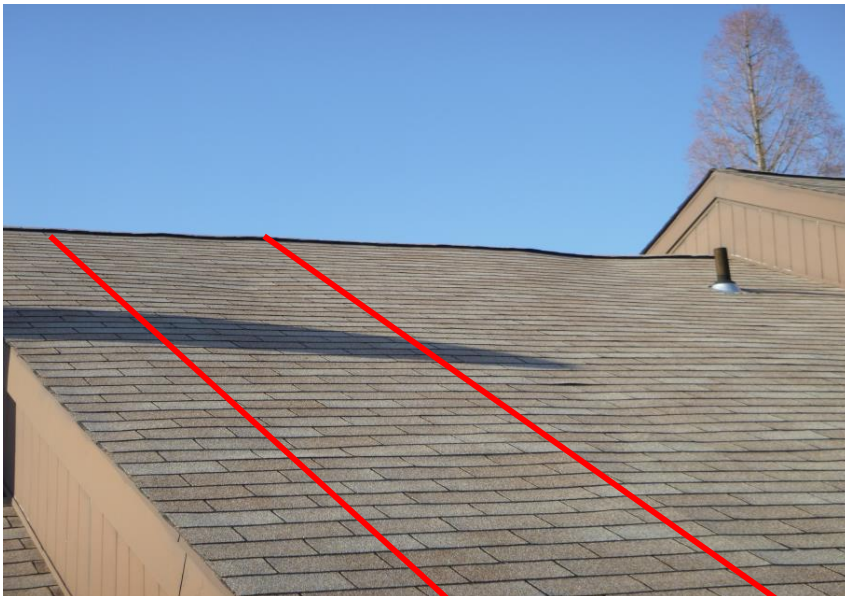
**Photo 8**

The original roof framing consists of roof trusses spaced at 24 in. o.c. with 1/2 in. plywood sheathing. At portions of the steep-slope roofs along the east elevation of Building 89, the profile of the roof joists is visible within the field of the roof, indicating an example of the sheathing substrate sagging between roof joists. The amount of roof sagging between trusses that we observed can be expected after 40 yrs of service with this roof truss spacing and plywood

The profile of the roof joists is visible through the asphalt shingle roofing (drawn on for clarity).

sheathing thickness. The sagging areas are not pronounced and are not pervasive, and can only be seen in certain lighting conditions and at certain angles of observance. At this time, this condition is not adversely affecting roof performance. The sagging should be periodically visually monitored by building maintenance staff to determine if this condition worsens. The sagging may eventually become more pronounced and shingles will start to deform if sheathing edge fasteners become disengaged from roof trusses, at which time the sheathing will become unsupported and will have to be repaired or replaced. Portions of the roof ridge along the same roof areas are wavy or out of plane. We suspect that the waviness along the ridge is caused by the variance in the plane of the roof trusses and substrate sheathing as a result of roof framing inconsistencies that occurred during the initial roof installation. This is also not imminently detrimental to the existing roofing assembly, but should be periodically visually monitored.

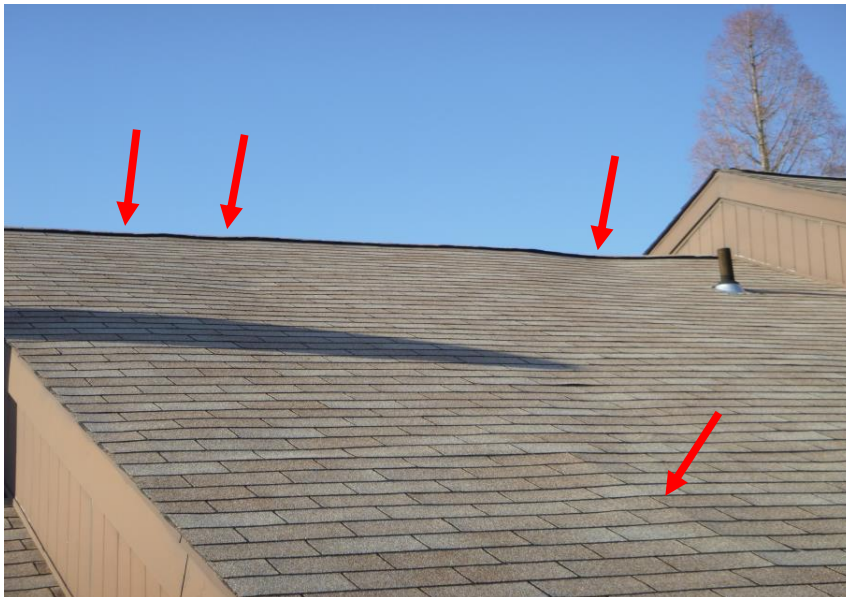
**Photo 9**

- Portions of the shingle-over ridge vent along the roof ridge at Building 89 appear significantly out of plane with the adjacent ridge vent (Photo 9). We could not verify the cause of this circumstance.

View of unevenness along the steep-slope roof ridge at the same location as Photo 8 above (top arrows). Note roof joist profile (bottom arrow).

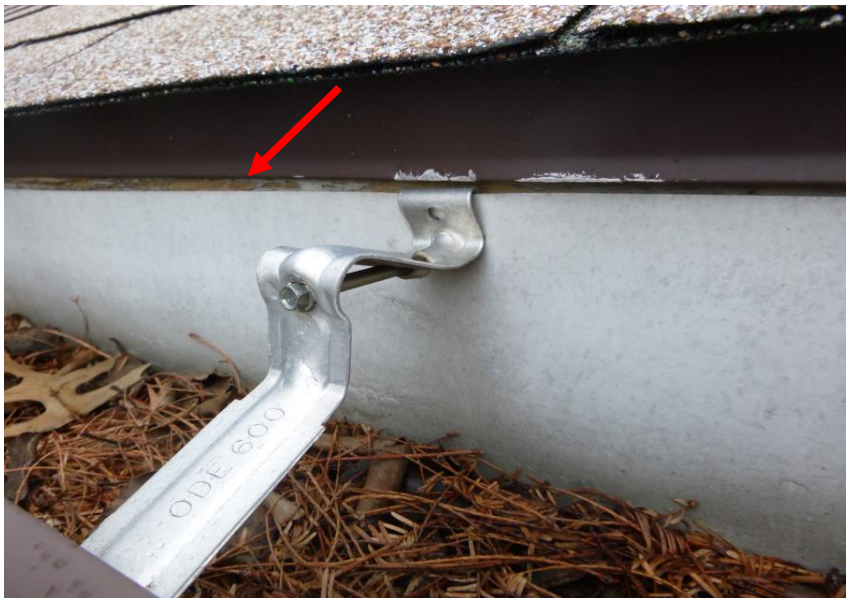
**Photo 10**

- The hung aluminum gutters include metal hangers/braces hooked into the exterior gutter leg and fastened to the fascia board through the interior gutter leg (Photo 10). Some hangers are spaced at varying distances along the gutters on each of the seven buildings, but generally are spaced at approximately 24 in. to 30 in. o.c. We did not observe significant deterioration, corrosion, or damage to the hangars or gutters.

View of one of the regularly spaced gutter hangers/braces within the hung aluminum gutters. Note the roof edge flashing does not counterflash the gutter.

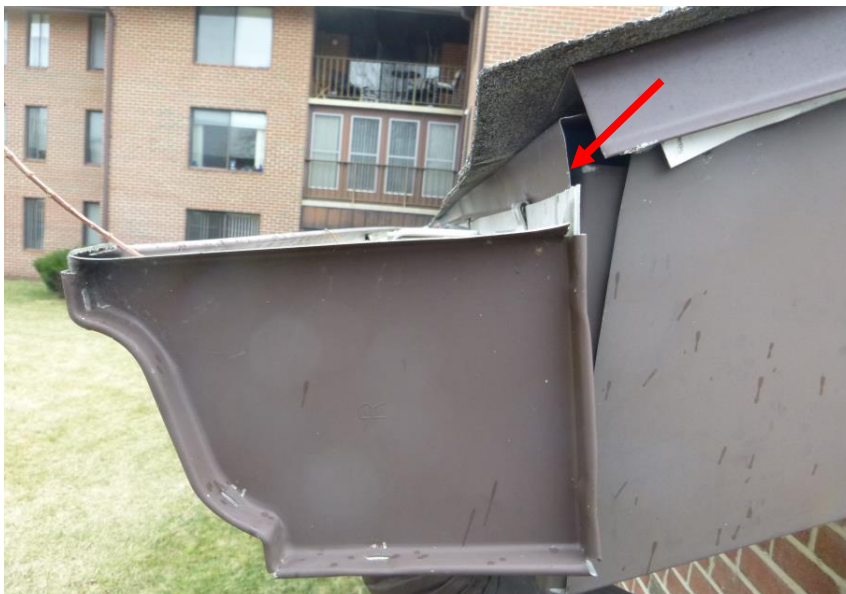
**Photo 11**

View of the metal counterflashing leg along the roof eave that extends behind the back leg of the hung gutter (arrow). Also note typical gutter end cap.

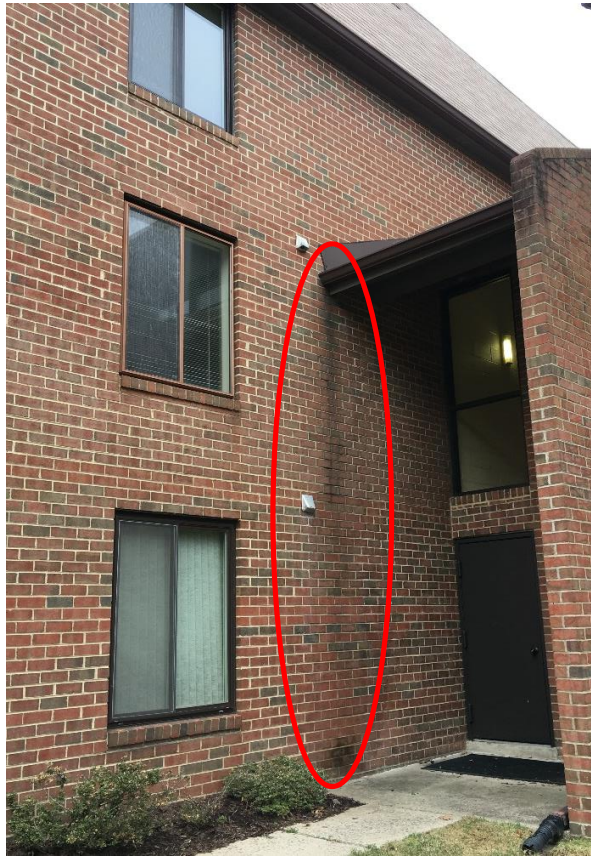
**Photo 12**

- At several locations, a gutter end cap abuts against the brick masonry cladding of adjacent building walls. The joint between the gutter and the brick is typically sealed along the top edge of the gutter end cap. We often observed black staining along the face of the brick below the gutter to wall joint (Photo 12). Staining typically occurs at the shorter gutter sections overtop the building stair tower exits. We did not observe a kick-out flashing on the roof at the gutter termination.

View of black staining along the brick masonry wall below a gutter end dam at the stair tower near the northwest corner of the building.

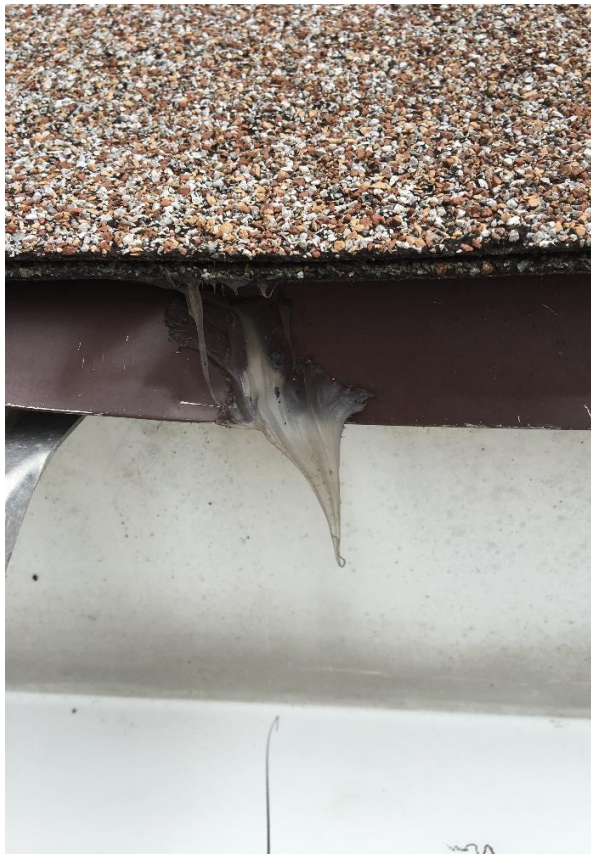
**Photo 13**

- The vertical leg of the roof eave flashing is cracked at the gutter length above the entrance at the northwest corner of Building 92 (Photo 13). Cracks are covered with clear sealant.

View of sealant over a crack in the roof eave flashing over the stair tower door near the northwest corner of the building.

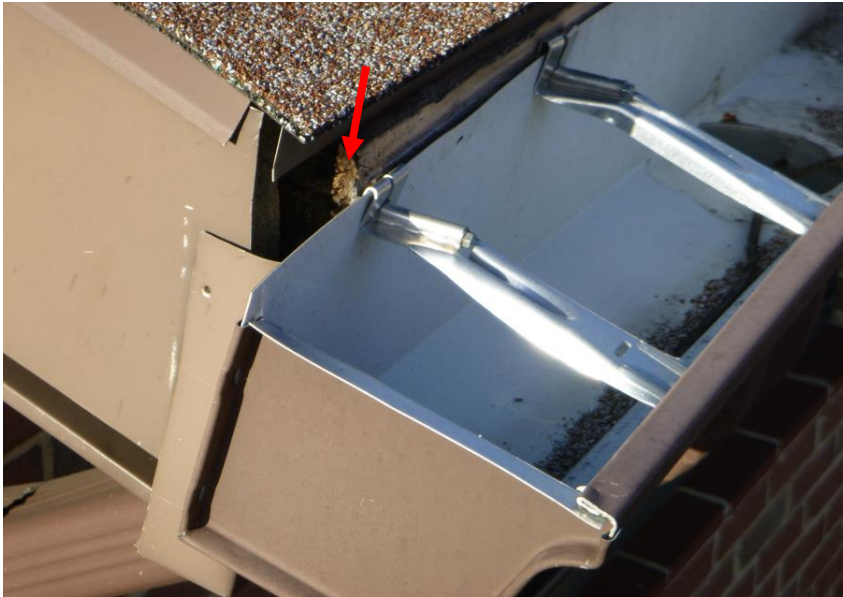
**Photo 14**

View of the gutter and fascia board that are pulling away from the roof framing (arrow).

The hung aluminum gutters are supported by regularly spaced lateral hangers/braces that fasten back into a wood fascia board along the roof eave. We observed several areas where the gutters are partially pulled away from the fascia boards and where the wood fascia boards are partially pulled away from the roof framing, typically near the roof edges. In areas where the gutter has pulled away, the roof edge flashing no longer laps over the back leg of the gutter. In some locations, the edge flashing stops short of the interior gutter leg or the gutter was installed with the interior gutter leg outboard of the roof edge flashing. Continued displacement of the gutter and fascia board may allow drainage to bypass the hung gutter and may damage the adjacent roofing. Building maintenance staff should consider retaining a roofing contractor to re-anchor or replace the fascia board and reinstall the gutters so that the roof edge flashing laps over the interior gutter leg, similar to intact gutters elsewhere on the buildings. In some locations, an additional piece of flashing may be required to extend the roof edge flashing slightly.

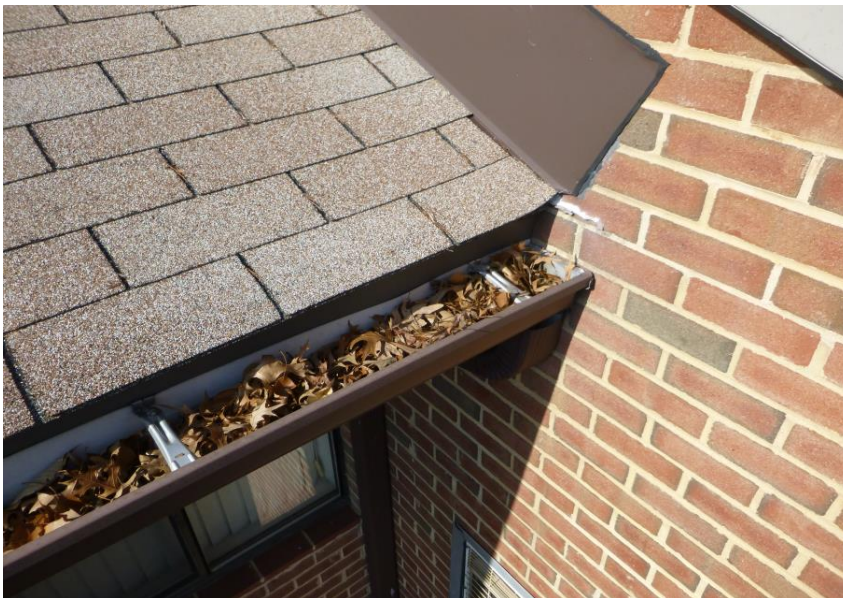
**Photo 15**

View of leaves built up in a section of gutter over the downleader inlet.

The steep-slope roofing drainage system consists of K-style hung aluminum gutters attached to a wood fascia board along the roof eaves. Gutters are generally sloped at 1/8 in. per foot to downleaders at either end of the gutter. Gutters drain to downleaders through an approximately 3 in. dia. hole cut into the gutter bottom leg. The gutters and downleaders are in generally good condition. However, we observed several areas leaves and other small debris has accumulated within the gutters. Buildup of debris within the gutters can block gutter or outlet flow and contribute to overtopping of gutters during rain events. The building maintenance staff should regularly review and clean debris from gutters and downleaders to promote drainage.

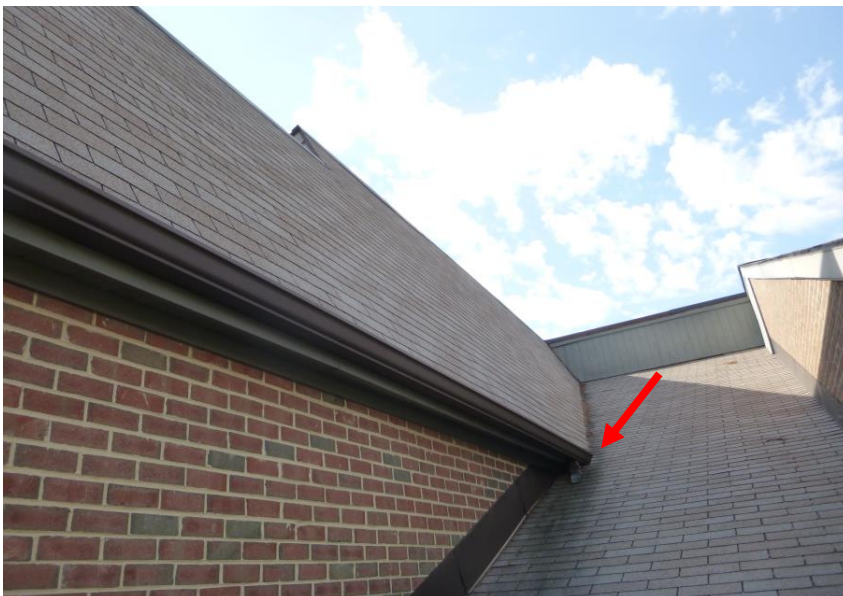
**Photo 16**

View of the Type Y roof gutter draining onto the adjacent Type X roof over the stair tower entry near the northeast corner of the building (arrow).

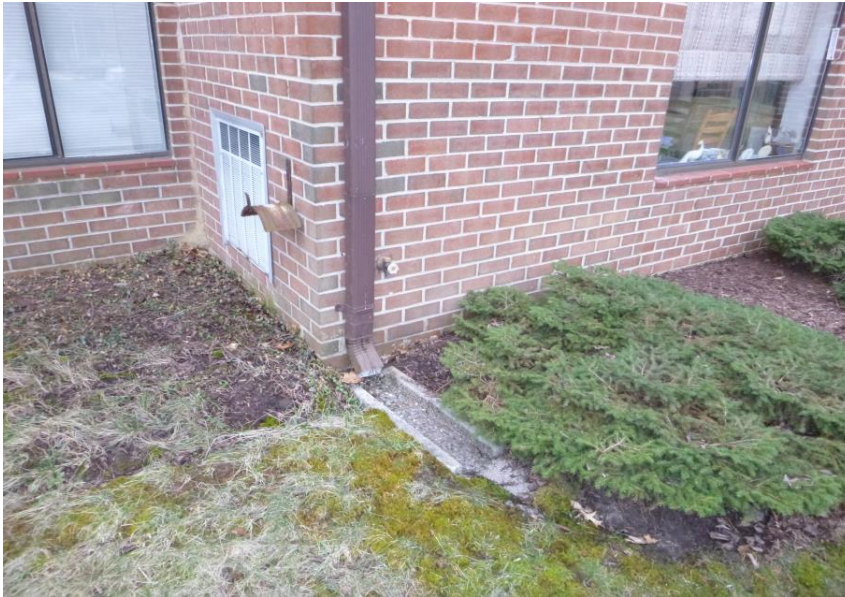
**Photo 17**

View of an above-grade downleader outlet draining over a concrete splash block.

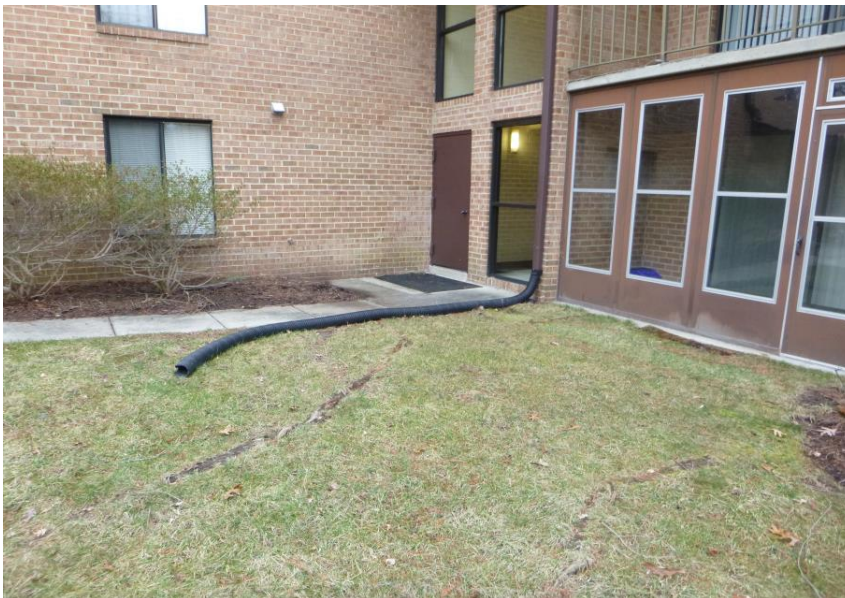
**Photo 18**

View of an HDPE pipe extension installed at a downleader outlet on the west elevation of the building.

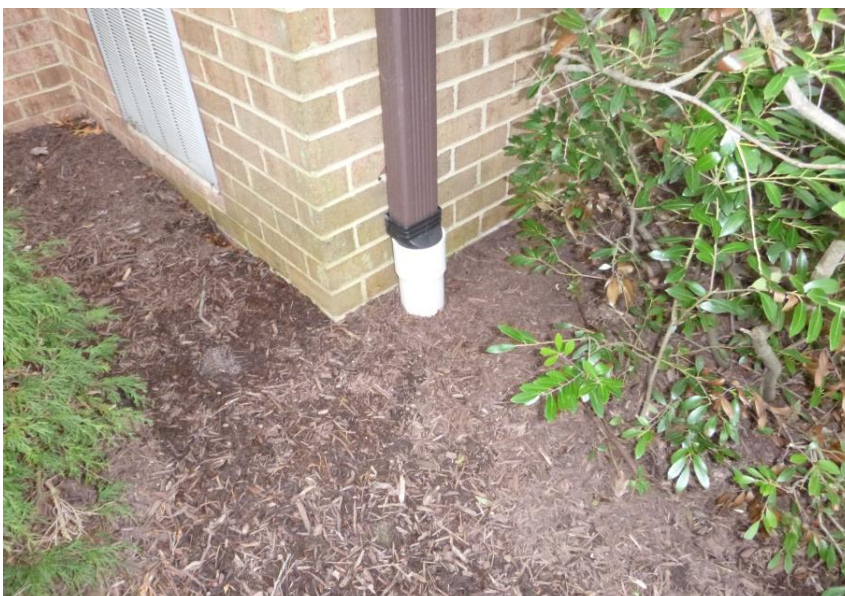
**Photo 19**

View of a downleader that drains below-grade through a PVC pipe.

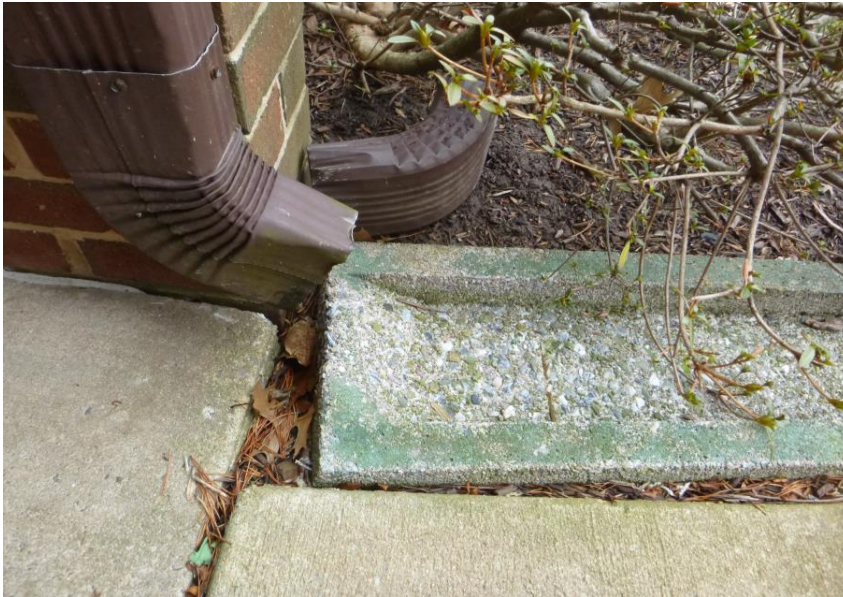
**Photo 20**

- We observed isolated downleaders where a portion of the at-grade outlet is disconnected. At two such locations at the secondary building entrances near the northeast corner of Building 88 and at the southeast corner of Building 91, the downleaders discharge adjacent to the concrete walkway (Photo 20).

View of the disconnected end elbow of the downleader outlet at the stair tower entrance at the northeast corner of the building.

associated with ponding from the downleader discharge or gutter overtopping is an issue. Building maintenance staff may consider conducting repairs to establish a uniform method of discharging gutter downleaders below-grade or away from the building walls and highly trafficked public walk areas to limit the risk of leakage to the interior. We understand that OC&L will address this issue and offer remedial recommendations as part of their Task Order 1 work scope.

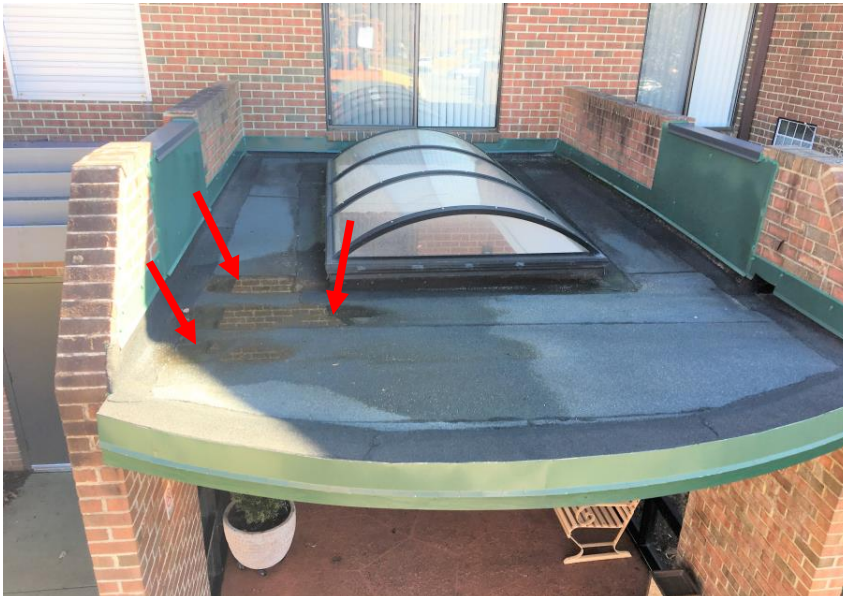
**Photo 21**

- We observed ponding on the built-up asphalt roof membrane at localized areas on some canopy roofs (e.g., Building 92) (Photo 21).

View of the low-slope canopy roofing and barrel skylight over the main building entrances. Water is ponded on the surface of the roof (arrows).

The low-slope roofing at the canopy is sloped-to-drain to through-wall scuppers, typically located at an exterior corner of the canopy. We observed several isolated areas of ponded water over the canopy roofs throughout the community. The 2012 edition of the International Building Code requires standing water to drain from the roof surfaces within 48 hrs of a rain event. Water that remains on the roof longer than 48 hrs can reduce the durability of the roofing membrane. Standing water on the membrane increases likelihood of leakage through seams and other discontinuities in the roof, reduces membrane service life, and leakage from ponding can create health concerns. We note that leakage to the building interior through the canopy may be unlikely due to the lack of interior space below except possibly at the rising building wall transition. However, leakage may compromise the integrity of the canopy framing or result in water dripping onto residents walking below. Repairs may include reconstructing portions of the existing roofing membrane to improve slope-to-drain or providing additional through-wall drains/scuppers and associated downleaders.

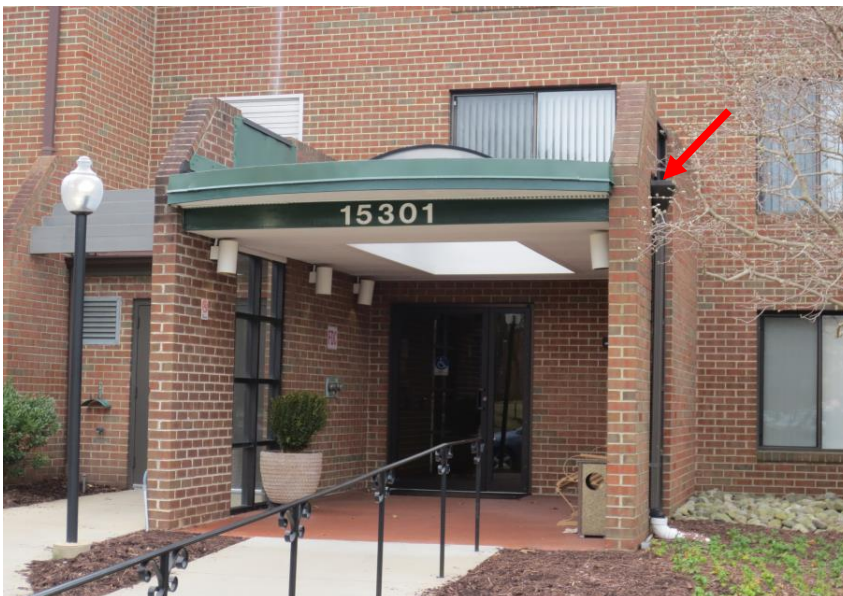
**Photo 22**

View of a main entrance canopy and the canopy scupper outlet that extends through the brick masonry wall.

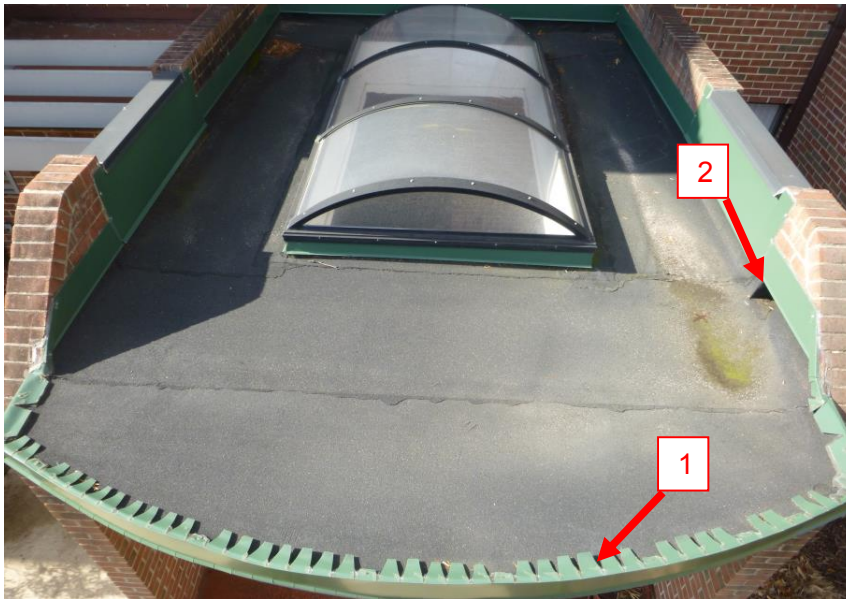
**Photo 23**

View of the exposed back leg of the main entrance canopy edge flashing (1) and the roof scupper (2).

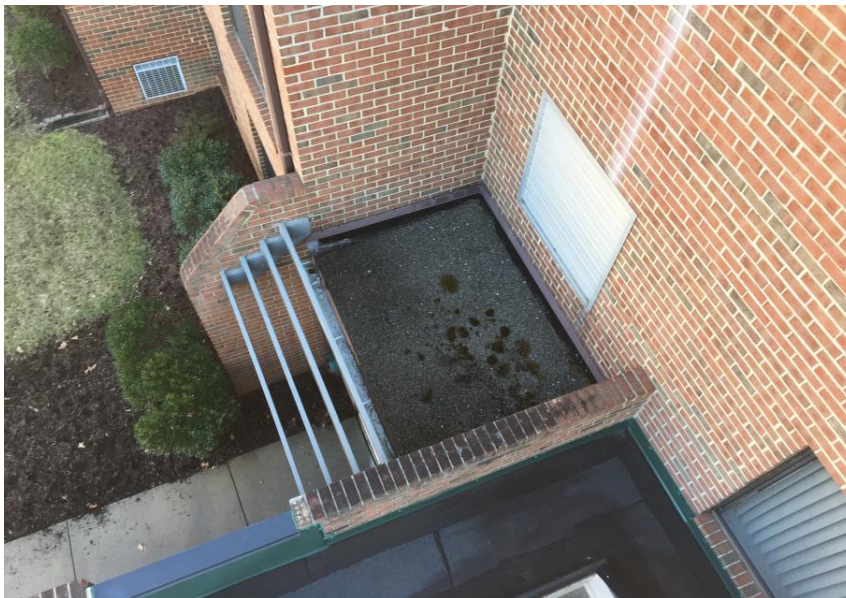
**Photo 24**

View of the trash room roof adjacent to the building main entrance.

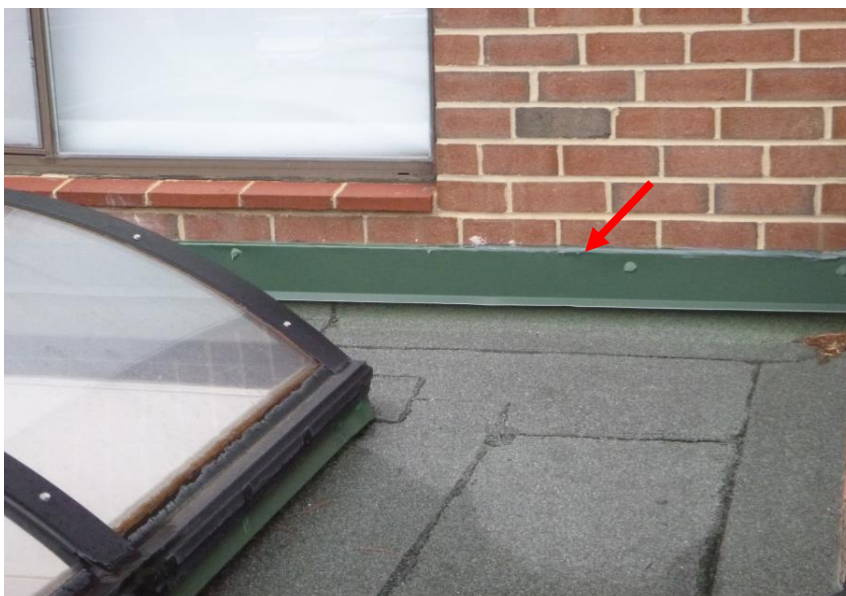
**Photo 25**

View of the roof-to-wall transition flashing above the canopy at the main entrance (arrow).

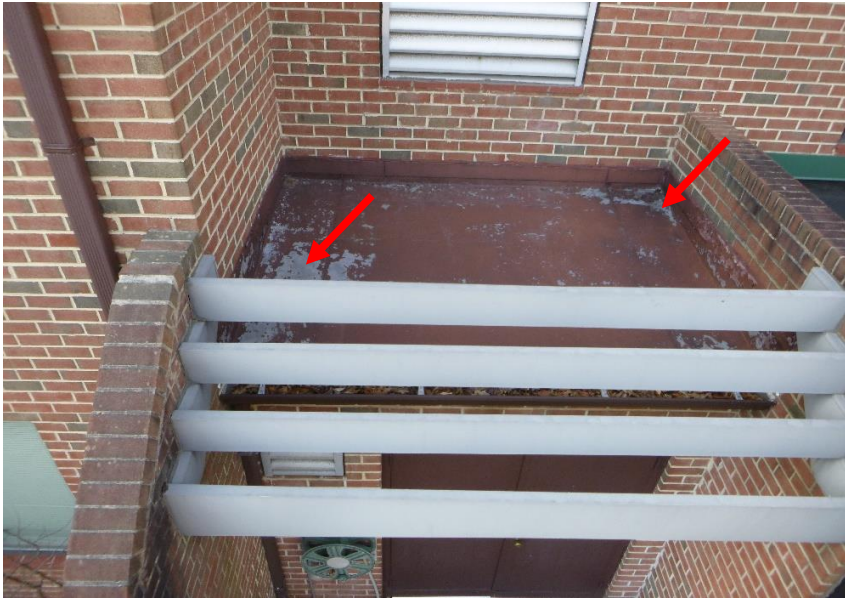
**Photo 26**

- The metal roofing and counterflashings over some of the trash room roofs appears to be covered with a red fluid-applied coating or paint which is flaking and missing in some areas (Photo 26). Surface corrosion is visible on the metal roofing at some locations.

While the metal roofing may still function to prevent water intrusion, we observed peeling and missing paint throughout the field of the existing metal roofs and surface corrosion where the paint is missing. If they do not already, we expect that the metal roofs will begin to show signs of aging (e.g., water leakage, metal section loss) in the next 5 yrs. Building maintenance staff may consider removal and replacement of the metal roofing with a modified-bitumen membrane roofing assembly to maintain consistency with some of the in-place canopy roofing assembly repairs. Alternatively, removal of surface corrosion/rust and peeling paint and application of a fluid-applied zinc-based coating over the existing roofing may prolong the useful service life of the roof an additional 5 to 10 yrs or more, depending on exposure conditions and the extent of corrosion of the existing metal roofing.

View of the trash room metal roof. The roof appears to be covered with a red coating or paint which is flaking and missing in some areas (arrows). Surface corrosion is visible on the roofing.

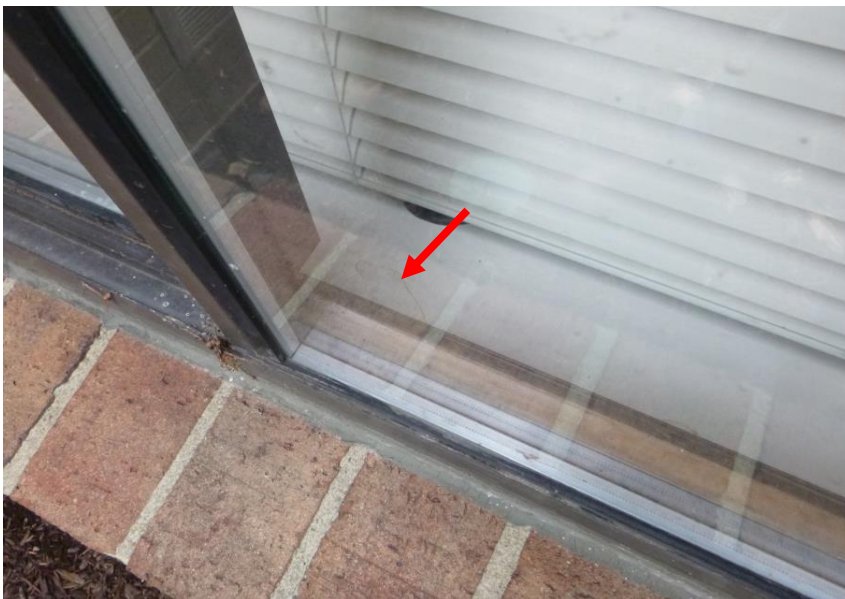
**Photo 27**

View from the building exterior of moisture stains (arrow) along the interior finishes at the sill of a window unit on the north elevation of the building.

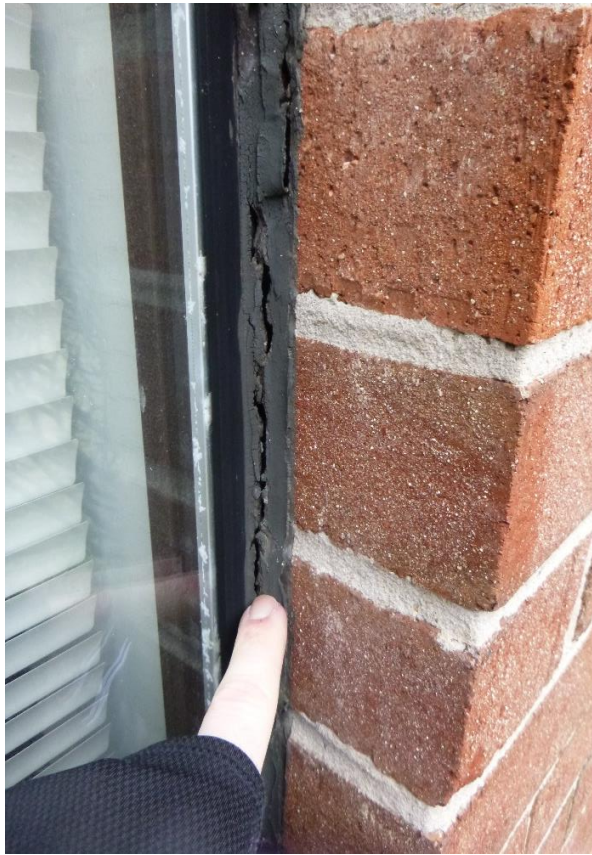
**Photo 28**

View of a cracked sealant joint along a window perimeter. We observed similar cracked sealant joints on the other buildings.

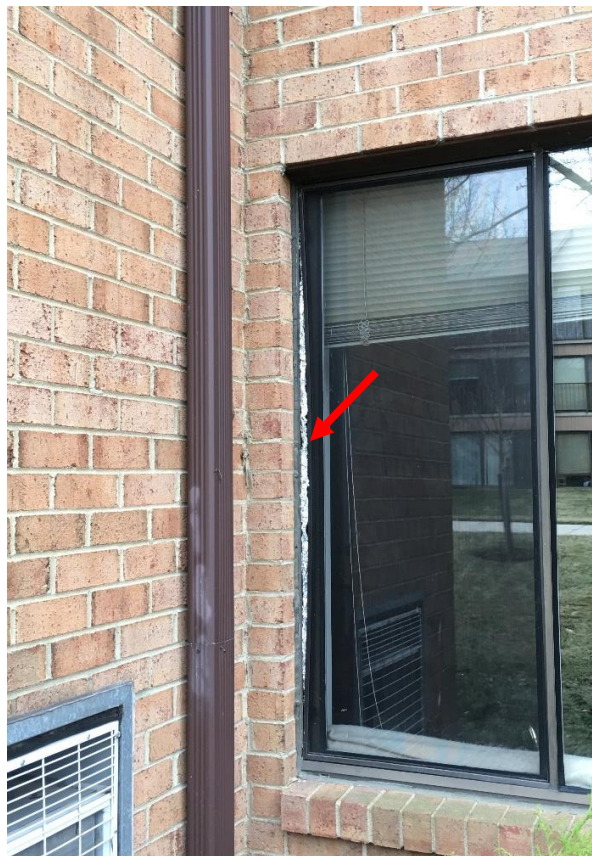
**Photo 29**

- Fenestrations generally consist of aluminum-framed windows with insulated glazing units (IG Units), set within punched openings in the brick masonry walls.
- Isolated window frames are broken at several buildings throughout the community (e.g., Building 92). The in-place aluminum frames appear in generally poor condition.
- We observed from the building exterior areas of moisture staining along the interior sill of isolated windows (Photo 27).
- Window and door perimeter sealant joints are typically in poor condition (e.g., cracked, split) (Photo 28). At one location we observed, along the front elevation of Building 93, the perimeter sealant joint is split open, and the opening is filled with aluminum foil (Photo 29).

View of aluminum foil shoved within a window perimeter joint at the north elevation of the building (arrow).

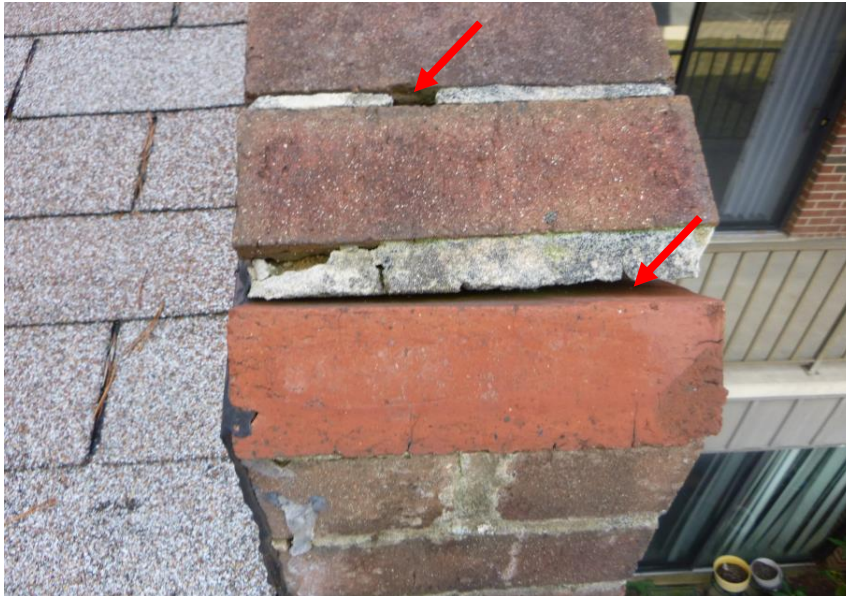
**Photo 30**

- At several locations (e.g., adjacent to building entrances, at the trash room), brick site walls extend out from the face of the building and include skyward-facing mortar joints. Several skyward-facing mortar joints are spalled, missing mortar, and are separated from the adjacent brick (Photo 30).

View of multiple spalled/missing sections of skyward-facing mortar at the brick masonry site wall near the stair tower entrance (arrows).

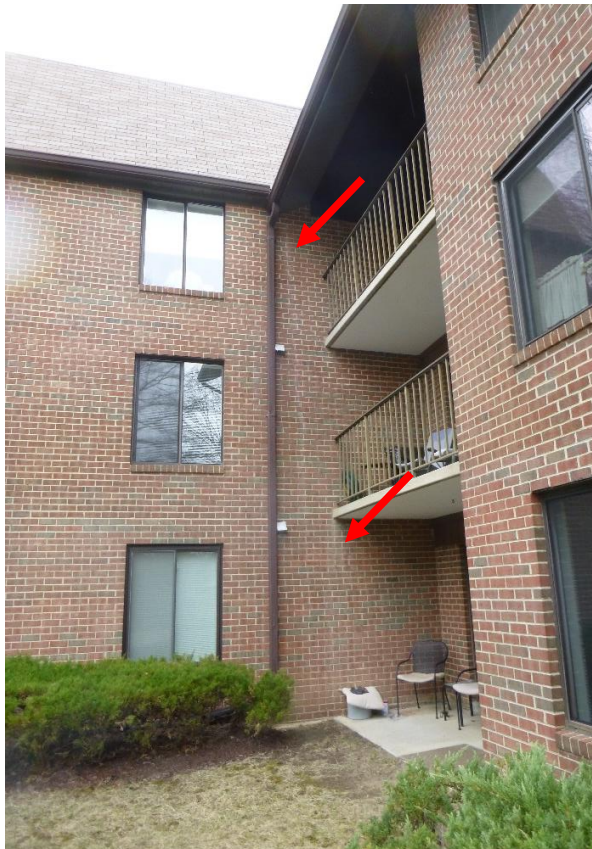
**Photo 31**

- Efflorescent staining and other discoloration is evident at numerous brick-clad areas. Often staining originates near the top of the building wall below gutter terminations or at balcony edges and extends down to just above grade (Photo 31).
