# RESERVE STUDY

## Council of Unit Owners Mutual 19B Condominium of Rossmoor, Inc.

**Silver Spring, Maryland**  
**October 19, 2021**

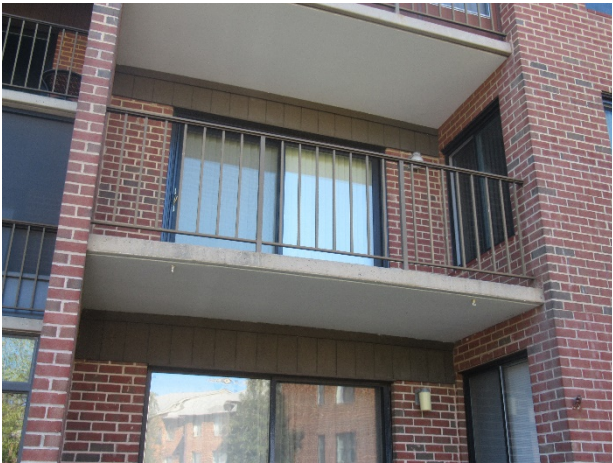
**Condition:** Good to fair overall with finish deterioration and carpets on balconies evident. As mentioned, we note carpet at the balconies. Carpet conceals concrete deterioration, retains water and inhibits drainage. Water trapped by the carpet can result in accelerated concrete deterioration. Therefore, we do not recommend the use of carpet on balcony surfaces.

**Concrete balcony overview**

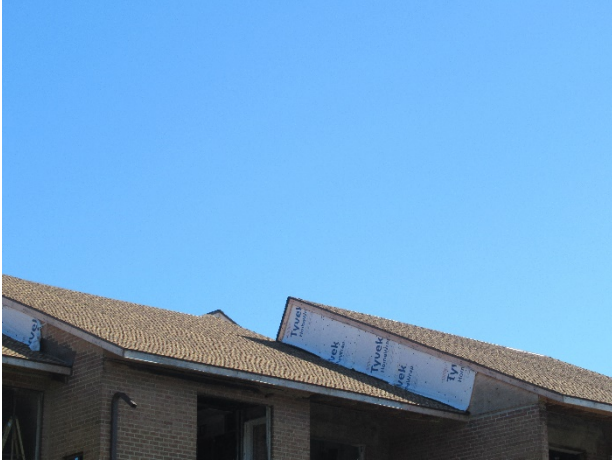
**Condition:** The roof at building 91 is in good condition overall. The roofs at the remaining buildings are in good to fair condition with shingle lift, sheathing deflection and isolated missing shingles evident. The Board informs us of a history of leaks with recent repairs conducted.

**Building 91 roof overview**

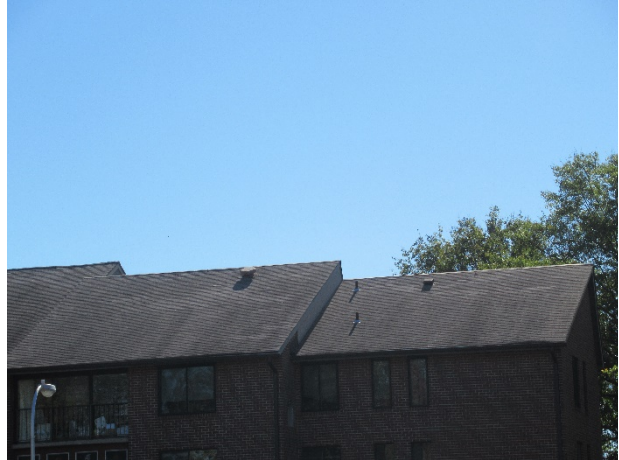
**Remaining roofs overview**

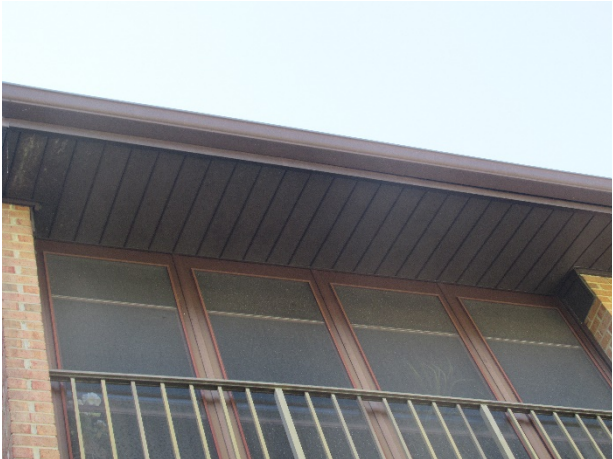
**Condition:** Good to fair overall with finish deterioration evident

**Aluminum soffit overview**

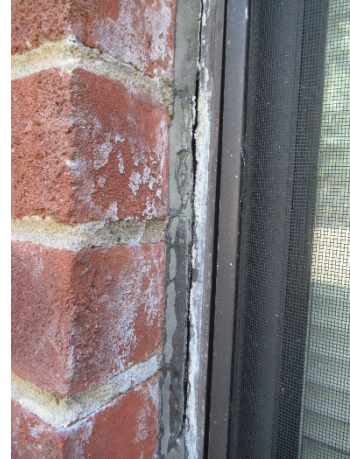
**Efflorescence and sealant deterioration at building 94**

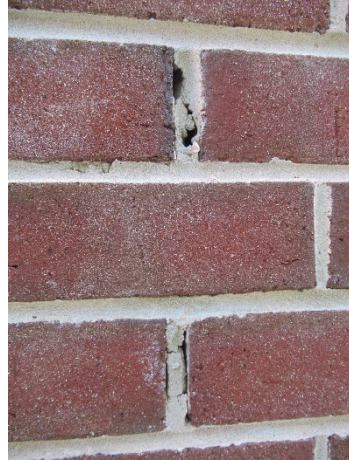
**Efflorescence and mortar deterioration at building 88**

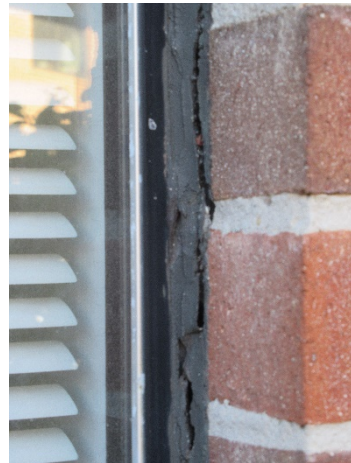
**Sealant crack at building 88**

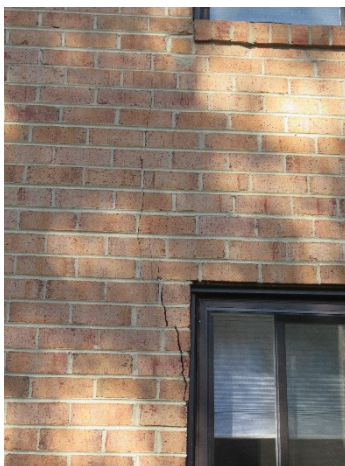
**Crack at Building 93**

***Useful Life:*** We advise a complete inspection of the masonry and related masonry repairs every 8- to 12-years to forestall deterioration.

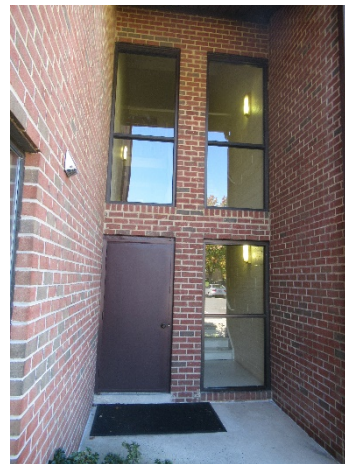
**Common windows and door overview**

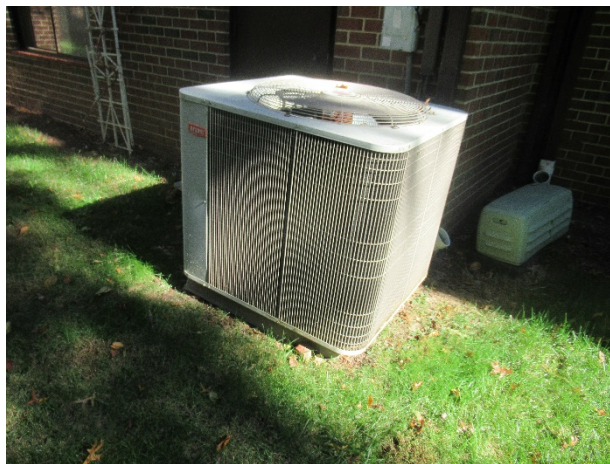
**Conditions:** Reported satisfactory without operational deficiencies

**Air handling unit overview**

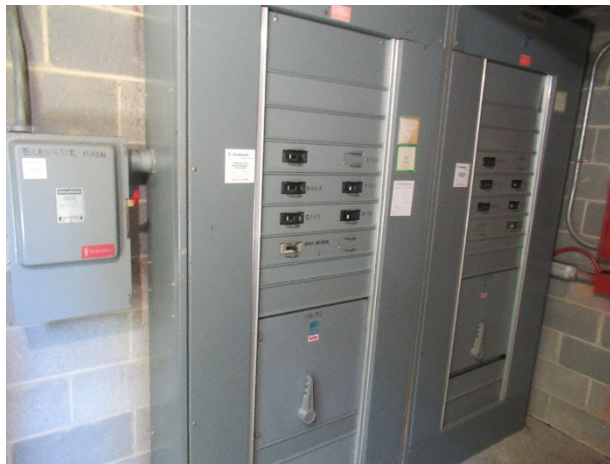
**Condition:** Reported satisfactory

**Electrical panel overview**

We recommend the Association conduct thermoscans of the distribution panels and circuit protection panels, and inspections of the transformers for any indications of arcing, burning or overheating on a regular basis, funded through the operating budget. Verification of the integrity of all connection points minimizes the potential for arcing and fires.

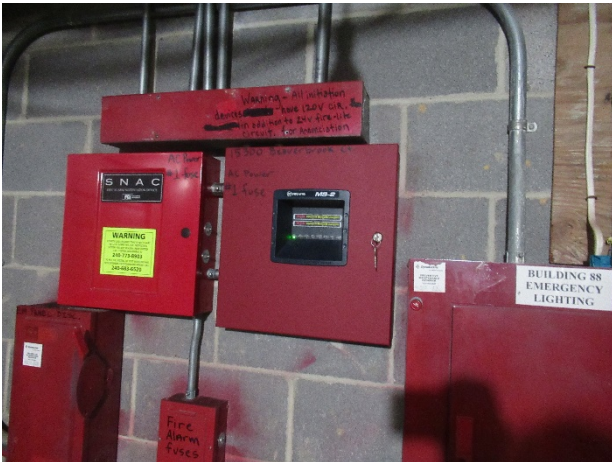
**Conditions:** Reported satisfactory

Control panel overview

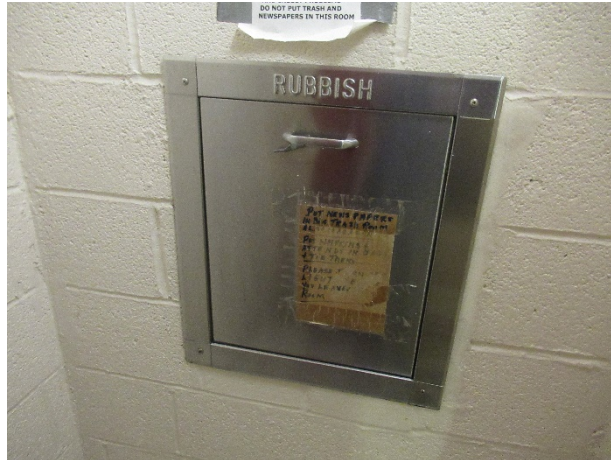
**Condition:** Reported satisfactory

**Trash chute overview**

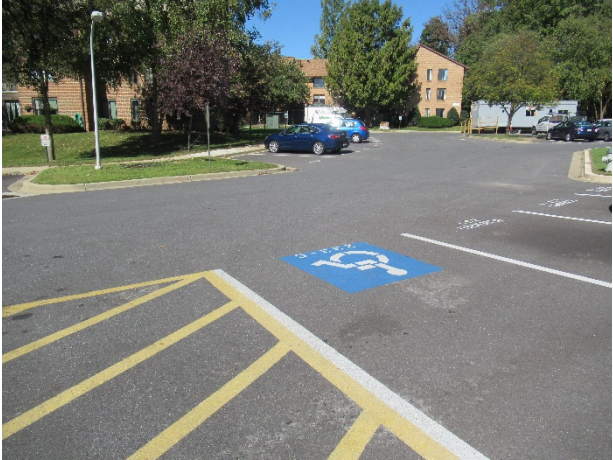
**Condition:** Good overall with vehicular fluid stains evident

**Asphalt pavement overview**

existing asphalt down to the base course of aggregate and native soil followed by the application of two or more new lifts of asphalt. We recommend mill and overlayment on asphalt pavement that exhibits normal deterioration and wear. We recommend total replacement of asphalt pavement that exhibits severe deterioration, inadequate drainage, pavement that has been overlaid multiple times in the past or where the configuration makes overlayment not possible. Based on the apparent visual condition and configuration of the asphalt pavement, we recommend the mill and overlay method for repaving at Mutual 19B.

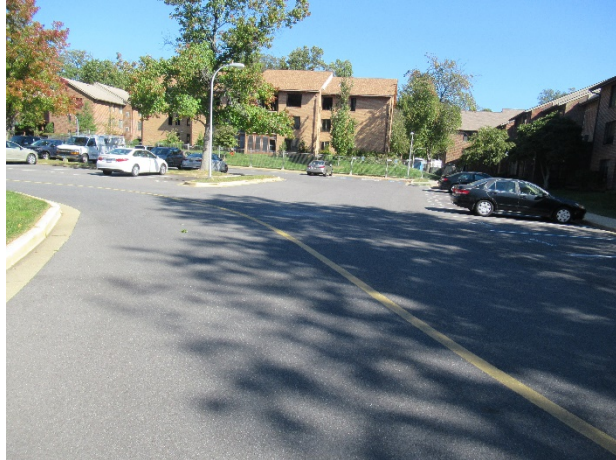
**Asphalt pavement overview**

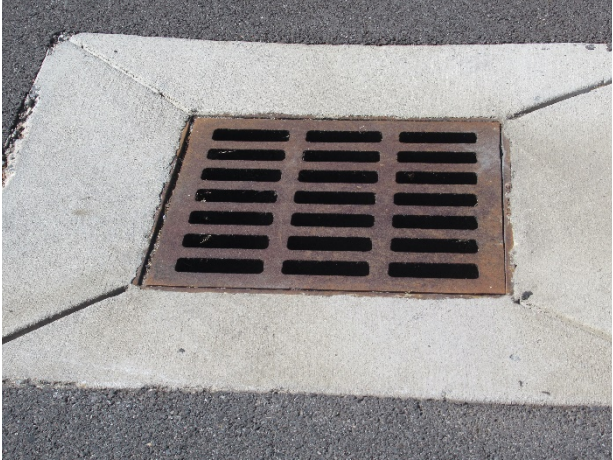
**Condition:** Good overall

**Catch basin overview**

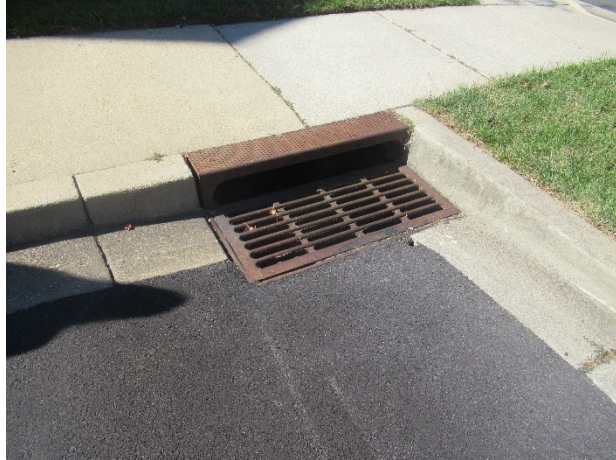
**Catch basin overview**

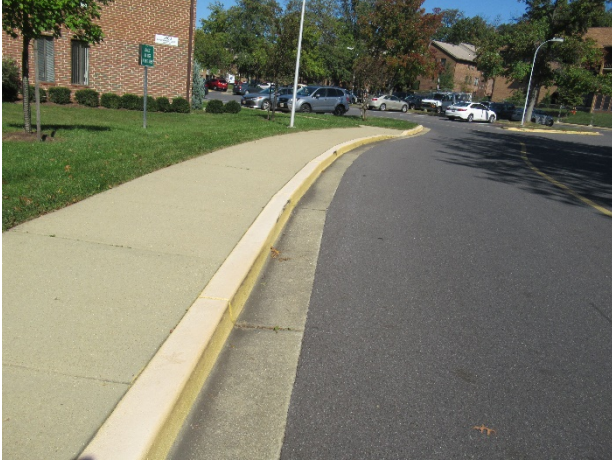
**Condition:** Good overall with isolated concrete spall

**Concrete curbs and gutters overview**

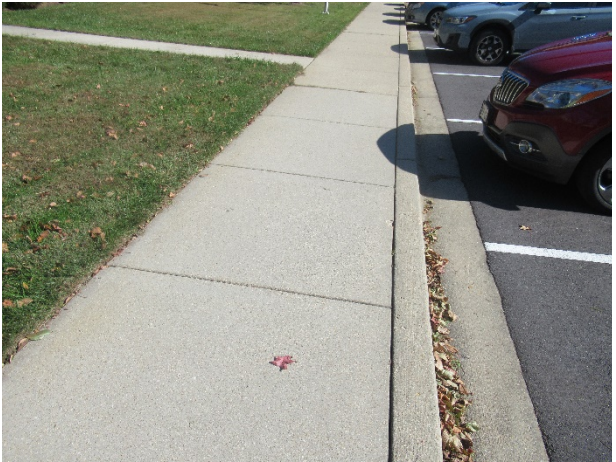
**Condition:** Good to fair overall with cracks, concrete scaling and isolated concrete undermining evident

**Concrete sidewalk overview**
