Project 180181 – Task Order 1: Storm Water Analysis/Gutter and Downspouts, Mutual 19B,  
Leisure World, Silver Spring, MD 20906

At the request of O'Connell and Lawrence, Inc. (OC&L), Simpson Gumpertz & Heger Inc. (SGH) performed a condition assessment and drainage analysis of the existing steep- and low-sloped roofing assemblies and integrated drainage components at the above-named project. This letter summarizes our observations and presents our conclusions and recommendations.

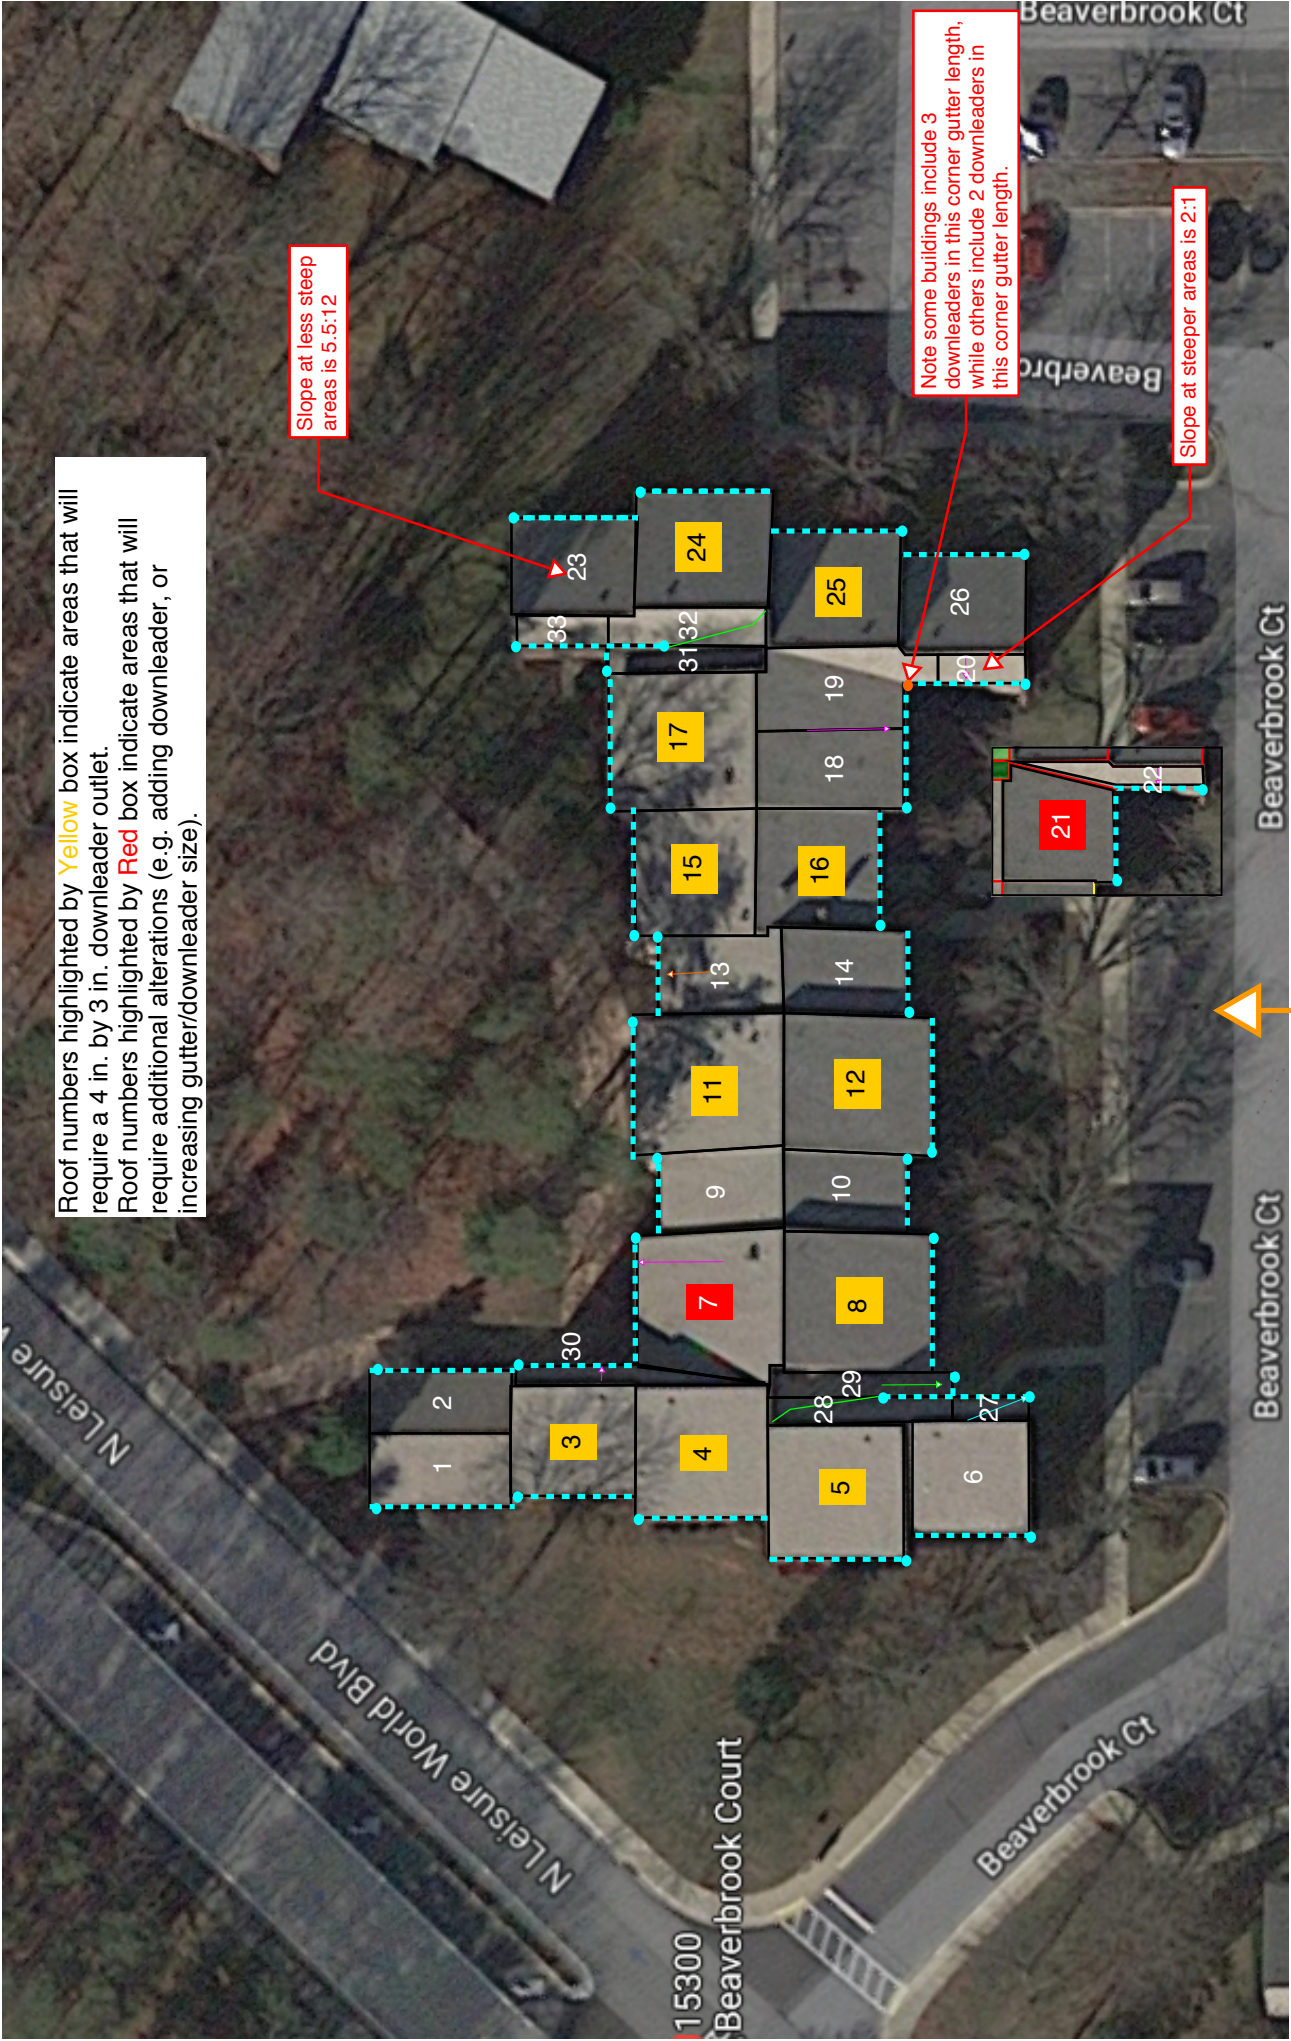
Note: Areas 18, 19, 20 represent the condition where there are 3 downleaders for that section of roof, while Areas 21 and 22 represent the condition where there are 2 downleaders for that section of roof.

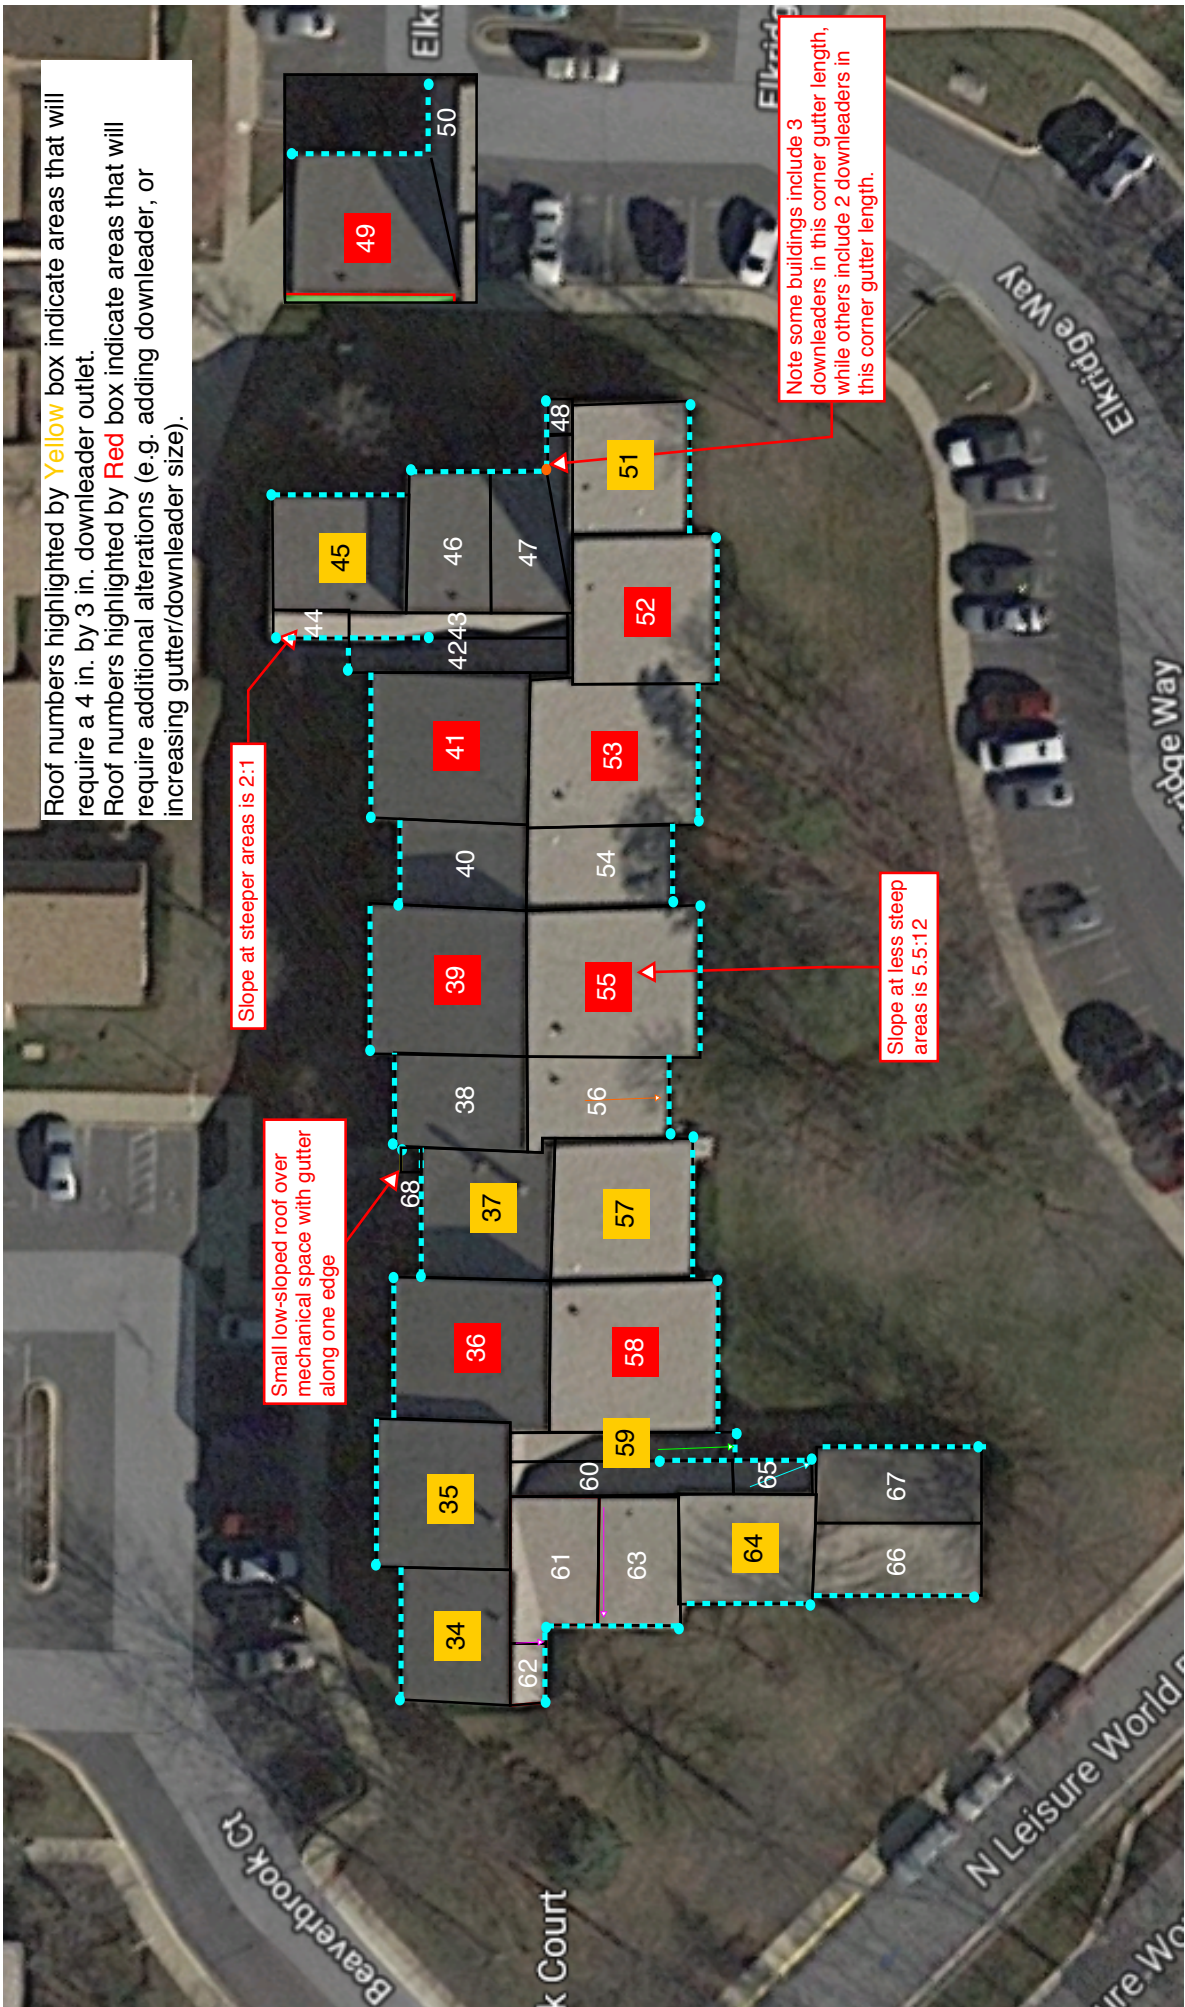
## Building Type 2

Note: Areas 46, 47, 48 represent the condition where there are 3 downleaders for that section of roof, while Areas 49 and 50 represent the condition where there are 2 downleaders for that section of roof.
