# RESERVE STUDY

## Council of Unit Owners Mutual 19B Condominium of Rossmoor, Inc.

**Silver Spring, Maryland**  
**October 19, 2021**

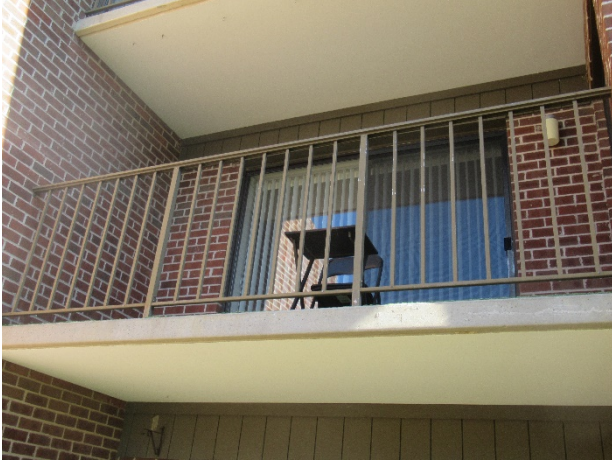
**Condition:** Fair overall with fade and finish deterioration evident

**Aluminum railings overview**

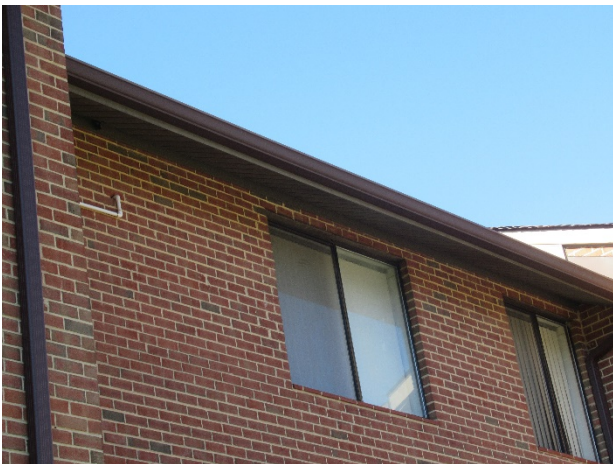
**Condition:** Good overall with isolated damage evident

**Gutter overview**

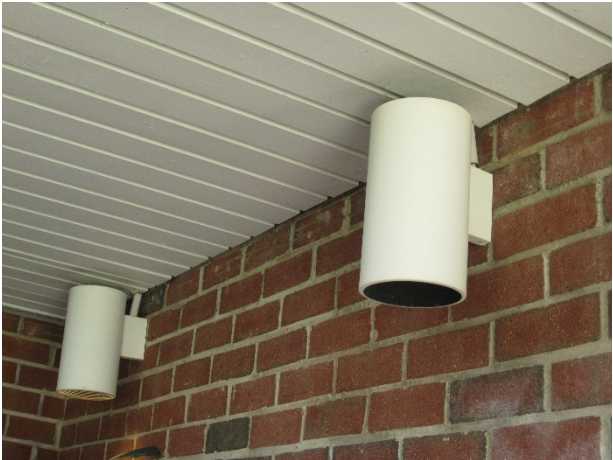
**Condition:** Fair overall with minor rust and finish deterioration evident

**Light fixture overview**

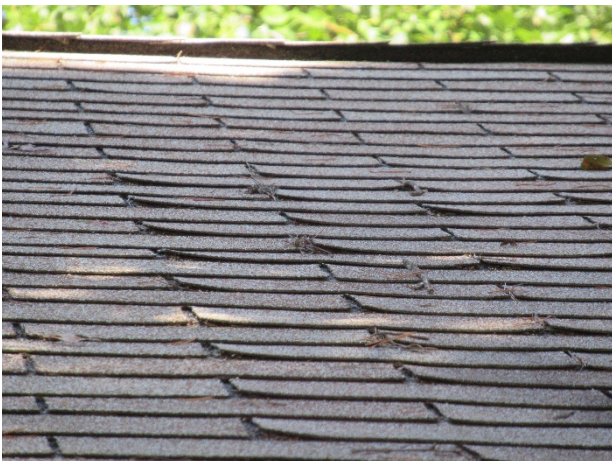
**Shingle lift**

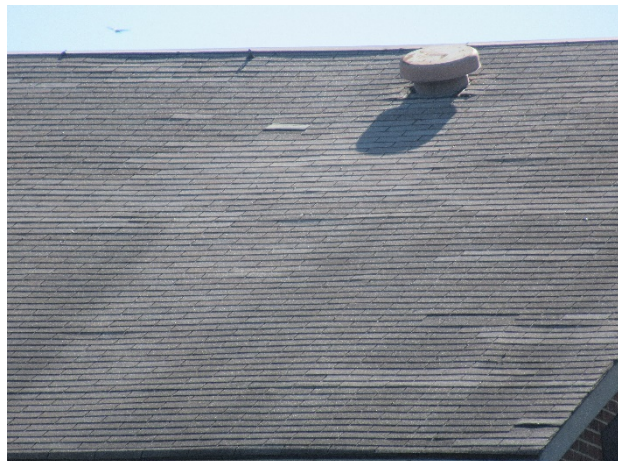
**Shingle lift**

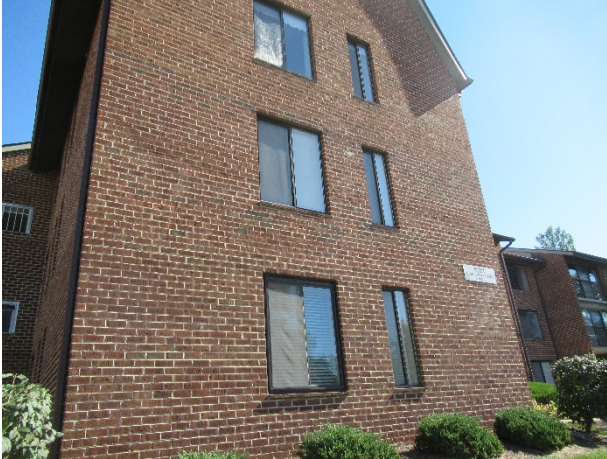
**Condition:** Fair overall with cracks, mortar deterioration, sealant deterioration, lintel rust, efflorescence and spalling evident.

**Masonry overview**

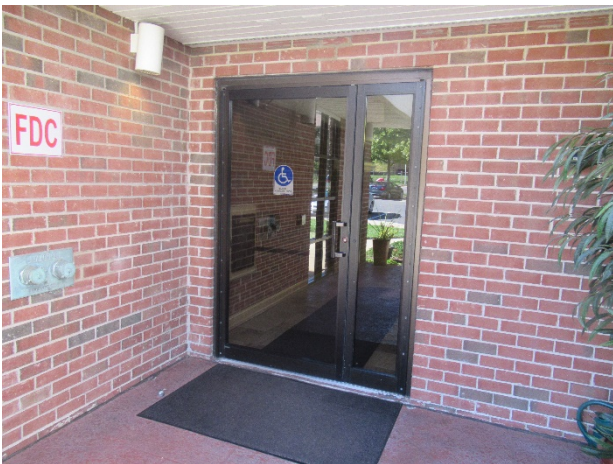
**Condition:** Fair overall with reports of unsatisfactory door operation and wear evident

**Common door overview**

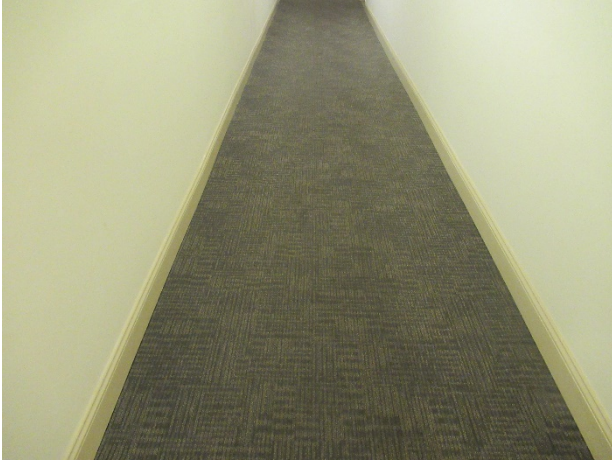
**Condition:** Fair overall with stains evident

**Carpet floor coverings overview**

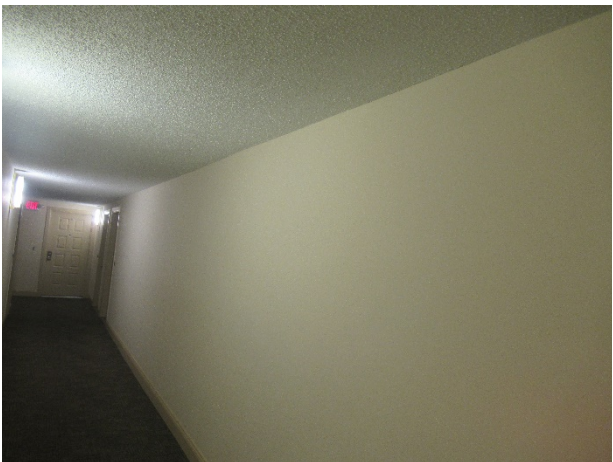
**Condition:** Fair overall with scuff marks and damage evident

**Paint finishes overview**

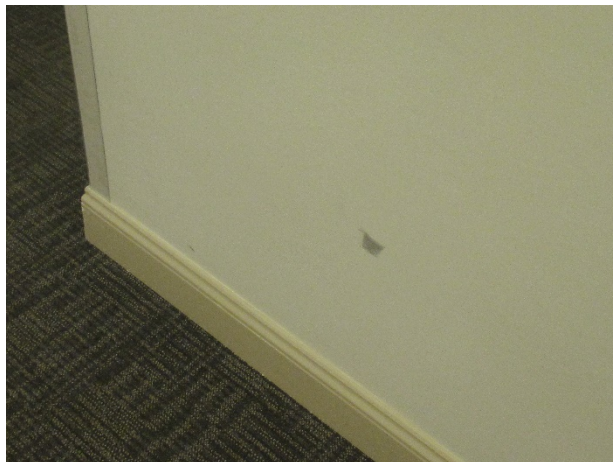
**Scuff mark**

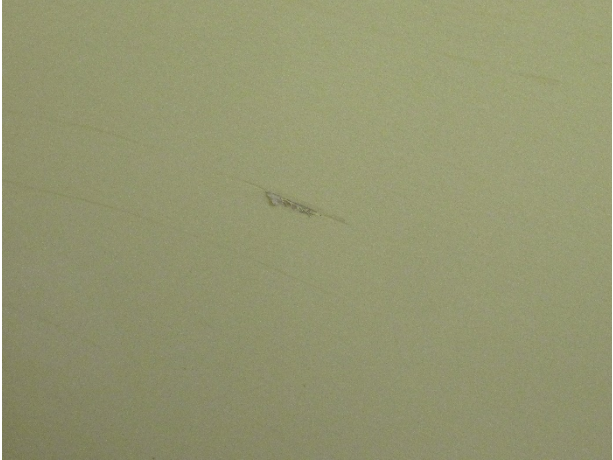
**Scuff mark**

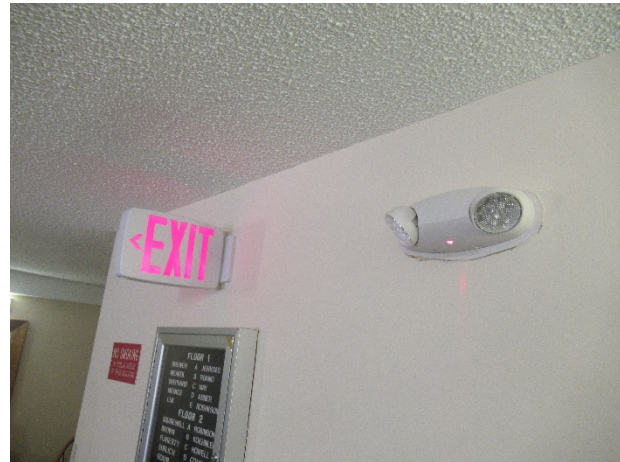
Life safety components overview

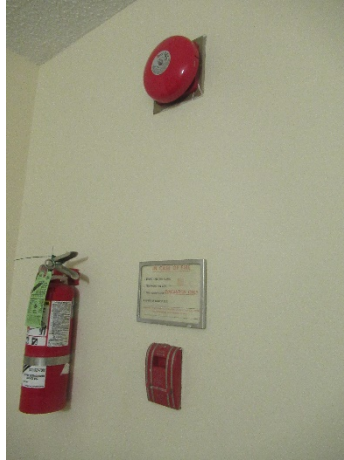
**Life safety components overview**

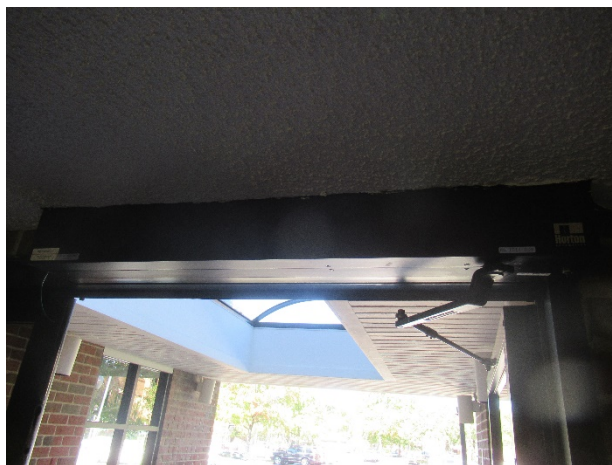
**Condition:** Reported satisfactory

**Automatic door operators overview**

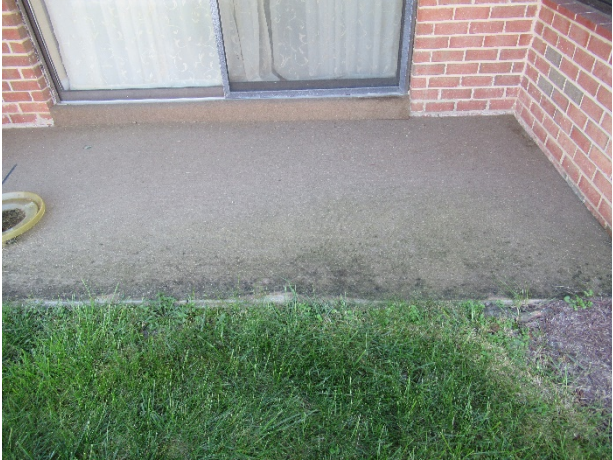
**Condition:** Good to fair overall condition with carpets on patios and cracks evident. As mentioned, we note carpet at the patios. Carpet conceals concrete deterioration, retains water and inhibits drainage. Water trapped by the carpet can result in accelerated concrete deterioration. Therefore, we do not recommend the use of carpet on patio surfaces.

**Concrete patio overview**

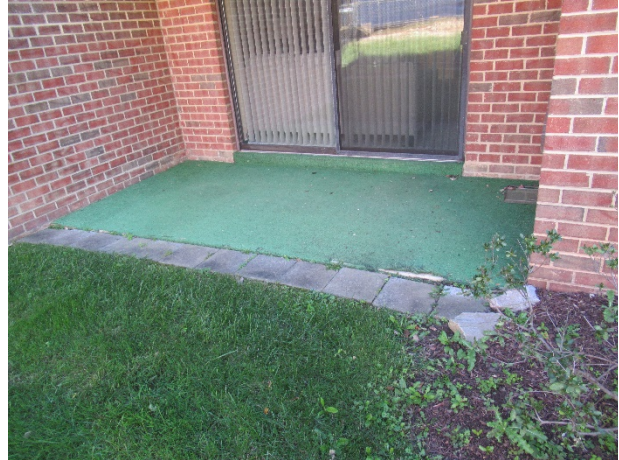
**Carpet on balcony**

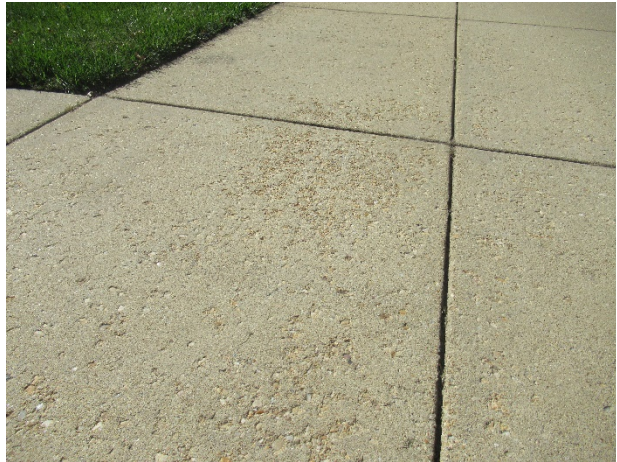
**Condition:** Good to fair overall with cracks, concrete scaling and isolated concrete undermining evident

**Concrete scaling**
